Analysis of Transformer Loadings and Failure Rate in Onitsha Electricity Distribution Network

Hachimenum N. Amadi*, Fabian I. Izuegbunam

Department of Electrical & Electronic Engineering, Federal University of Technology, Owerri, Nigeria

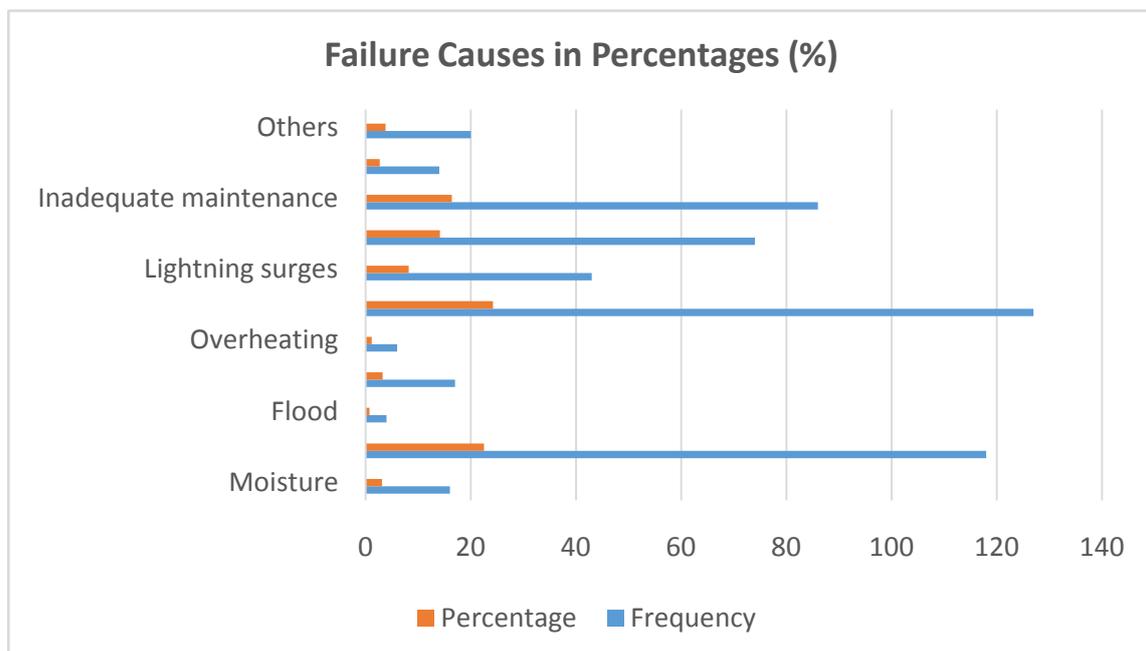
Figure 5. Classification of failure cause by percentage during 2011-2015

Results of the analysis presented in Table 3 shows that Insulation Issues topped the list of failure causes in the distribution network with 24.2%. This was followed by Overloading and Inadequate Maintenance with 22.5% and 16.4% respectively. The study thus established the following causes of transformer failures in the Onitsha electricity distribution network (See Table 3 and Figure 5):

6. Insulation Failures – These were the leading causes of failure as affirmed by this study. This category excludes those failures where there was evidence of a lightning or a line surge. There are actually four factors that are responsible for insulation deterioration: pyrolosis (heat), oxidation, acidity, and moisture. But moisture is reported separately. The average age of the transformers that failed due to insulation Issues was 18 years. In this study, insulation breakdown has been found to be the major cause of transformer failures in the Onitsha electricity distribution network followed closely by overload.

The identified causes of the transformer failures in the Onitsha electricity distribution network during the period 2011-2015 have been expressed in terms of percentages in Figure 5.

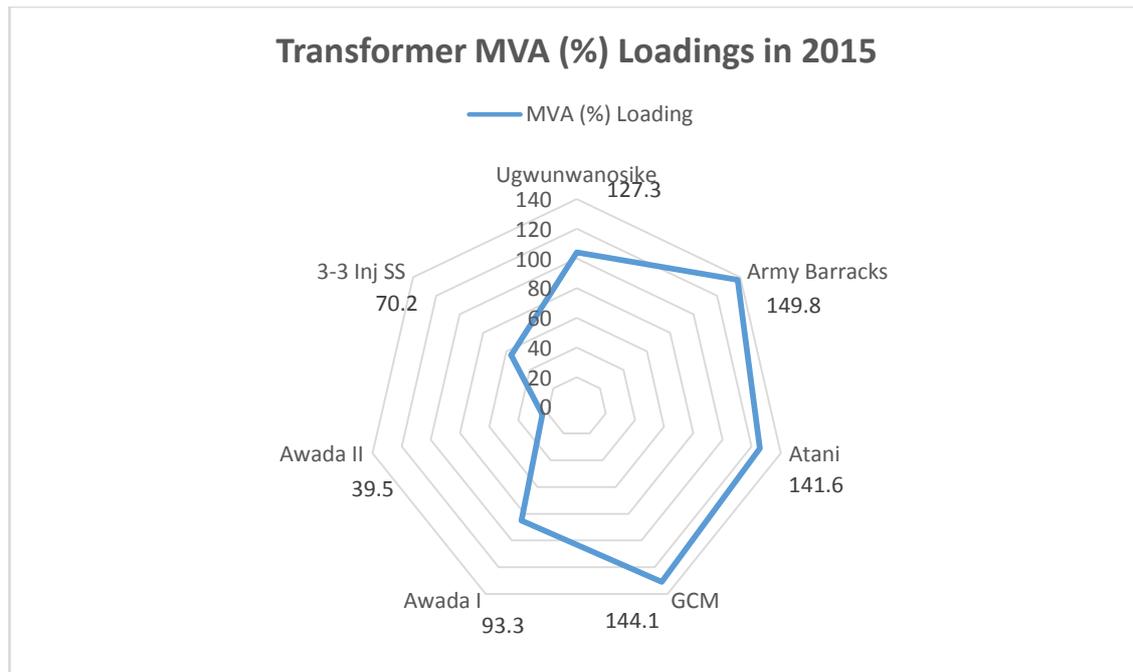
Figure 6. MVA Loading of transformers at the sampled Injection substations in Onitsha distribution network in 2015

The computed transformer MVA loadings in each of the injection substations studied during the period 2011-2015 are as presented in Table 4 while Figure 6 shows the loadings for the year 2015 only.

Observe that many of the transformers are loaded well above 100%. It is obvious also from Figure 6 that the loadings on the transformers increased steadily over the years as the power consumption increased leading eventually to the failure of the affected transformer units.

The findings of the study showed that during the period covered by the research, about 60% i.e. four out of the seven Injection substations in the distribution network had various transformer units loaded beyond the nameplate ratings.

It is obvious that this high percentage of overloaded transformers contributed significantly to the rapid deterioration of the transformers insulating materials and therefore the high rate of transformer failures as recorded in the study.
