Analysis of Reasons of Steam Turbogenerator Failure

Abstract Steam turbogenerators are often used for production of electric energy in companies where sources of steam with necessary technical parameters are produced in technological process. Attention is devoted in the paper to state analysis of steam turbine after failure and possible causes of its damage.

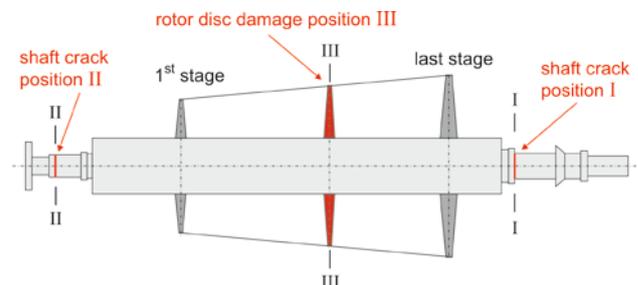
After removing of lids of bearing houses as well as lid of steam turbine body was found out that the turbine rotor was damaged in several locations (Figure 3).

Figure 3. Turbine rotor with locations of failures

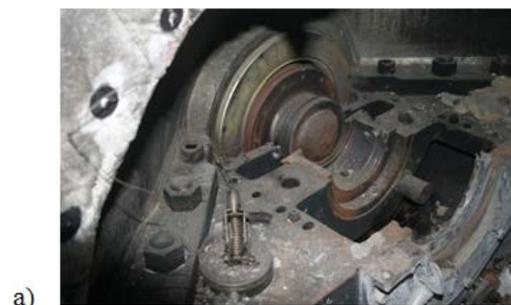
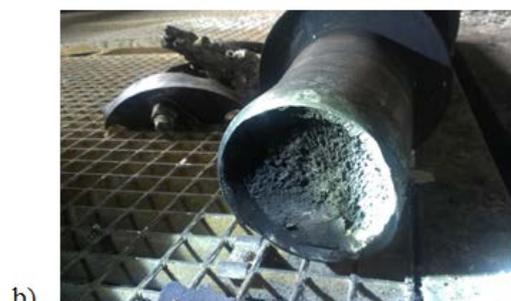
Figure 4. Damage of turbine rotor shaft in cross-section I-I

The shaft of steam turbine was damaged in two cross-sections. In cross-section I-I (Figure 3) the damage of turbine rotor shaft occurred before radial bearing on the side of reduction gear box (Figure 4a) with detail view into fracture surface of broken shaft part in Figure 4b.

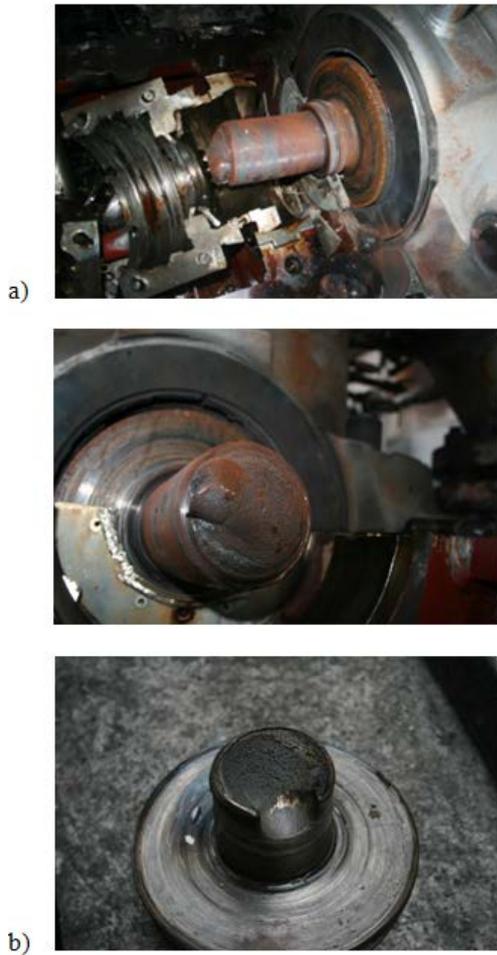
In cross-section II-II (Figure 3) the damage of turbine rotor shaft occurred between radial and axial bearing on the side of steam inlet of turbine (Figure 5a). Detail view to fracture surfaces of both parts of shaft after failure is given in Figure 5b.

Figure 5. Damage of turbine shaft on the side of axial bearing (cross-section II-II)

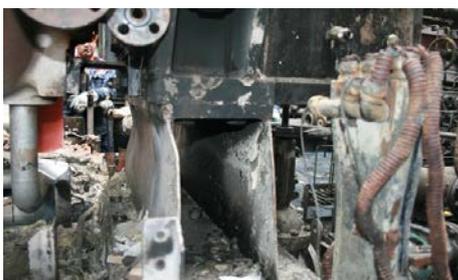
After disassembling of turbine covers was found out that the support on the side of axial bearing (Figure 6) is designed such a way that allows thermal dilatation of turbine rotor, but this design does not ensure house shifting to be in the same horizontal plane. This structural part it invokes excessive structural vibrations and consequently increasing of cyclic loading during operation. The deformations are documented in Figure 7.

Figure 6. Support on the side of axial bearing

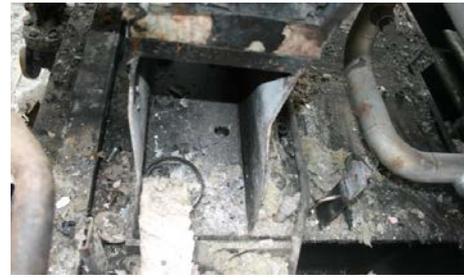
Figure 7. View to the deformed support on the side of axial bearing

On the basis of results gained by analytical and numerical modelling, experimental determination of mechanical properties as well as visual control after damage of turbine and consecutive inspections we have arrived to meaning that primary reason of failure was deterioration and damage of axial bearing of turbine which led to contact of fifth rotating wheel with sixth distribution wheel. The friction had led to repeating increasing of temperatures (at the location of contact the temperature could reach 1300 °C) with consecutive cooling by flowing medium (steam). This process initiate creation of oxidic layers that caused change of structure and material properties of material leading to weakening of fifth stage of rotating wheel in location of increasing temperature. At the time of failure, the fifth stage was damaged in the location of stress concentrator (one of three hole in the disc) and disc locking led to impact with consecutive plastic deformation and damage of journals of turbine rotors in location of radial bearings from internal side. This damage of rotor and high temperature due to friction caused fire because of failure in hydraulic piping.

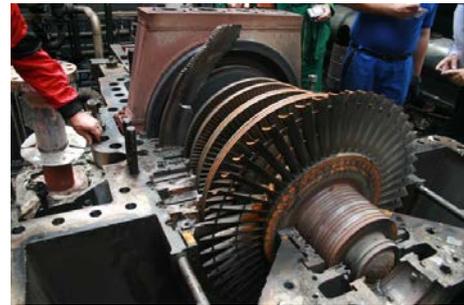
After disassembling of upper turbine body was found out that the fifth stage (section III-III Figure 3) of rotor disc is damaged along whole circumference, see Figure 8. Deformation of disc part in radial direction occurred during disassembling of upper turbine cover.

Figure 8. Damaged rotor disc on the fifth stage

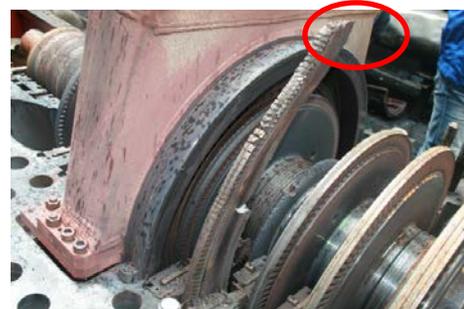
It is apparent from Figure 9 that the part of disc remaining on rotor shows remarkable changes resulting from variable thermal loadings that according to our guess could reach up to 1300°C. This heating could be result of fact that the damaged disc undergoes friction with the holder blades of the sixth stage – see detail in Figure 10.

Figure 9. View to disc part remaining on rotor

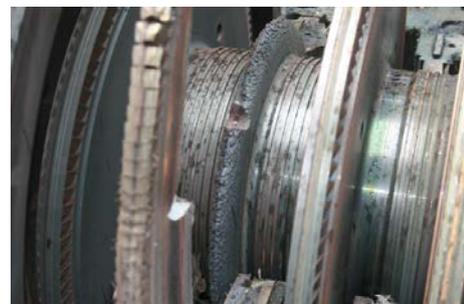
Figure 10. Detail view to damaged rotor disc

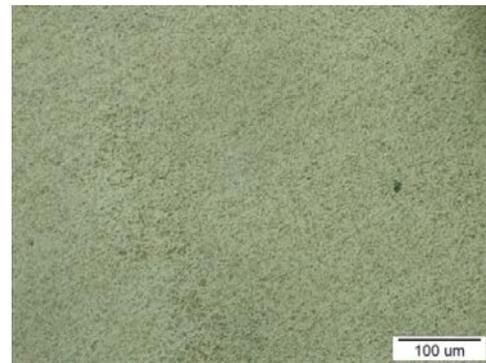
Figure 14. Microstructure of specimen A – tempered martensite - sorbit

Microstructure in Figure 14, Figure 15 and Figure 16 represents tempered martensite - sorbit (Figure 14) and microstructures in Figure 15 and Figure 16 contain carbidic elements. Figure 17 documents a crack initiated from the surface.

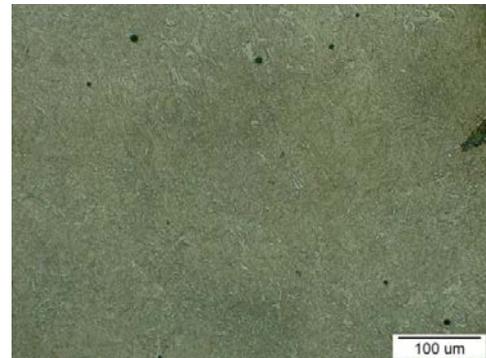
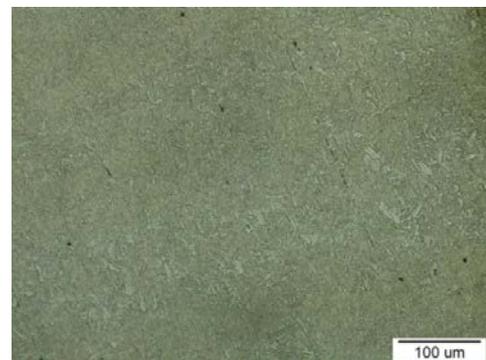
Figure 15. Microstructure of specimen A – coarse carbide parts

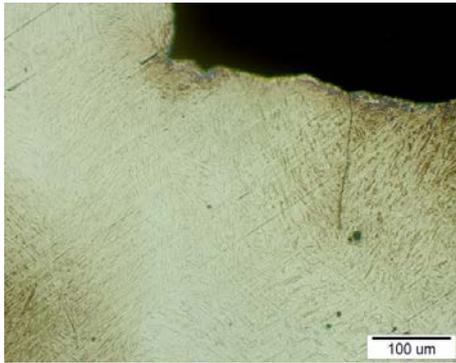
Figure 17. Microstructure of specimen A with a crack initiated on surface

Hardness of basic material with sorbit structure is in range from 340 HV10 to 390 HV10. Microstructure of surface was changed by multiple phase transformations due to thermal influences and their hardness is in range from 430 HV10 to 470 HV10.

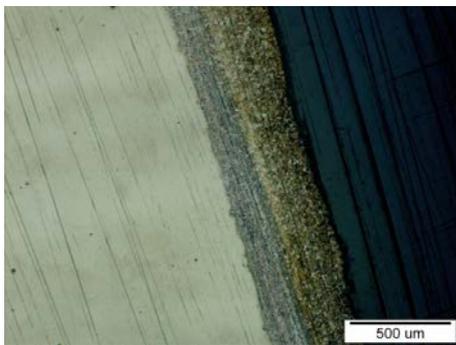
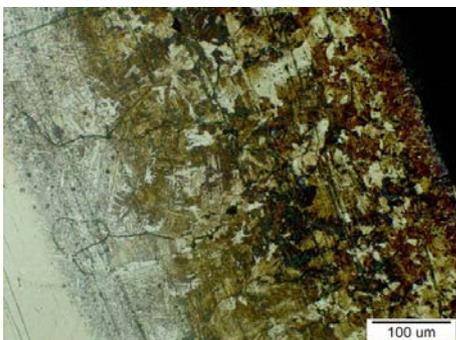
Microstructure of sample B is shown in [Figure 18](#) and [Figure 19](#) and it shows that intensive oxidation of surface occurred which resulted to creation of several oxide layers. The thickness of oxidic layer was cca 0.4 mm. The structure in this area is significantly heterogeneous with presence of many cracks in layer (especially at the bottom part), [Figure 19](#).

Microstructure of sample B is similar to that of sample A. Hardness determined for sample B was cca 280 HV10 for basic material and cca 450 HV10 for surface layer.

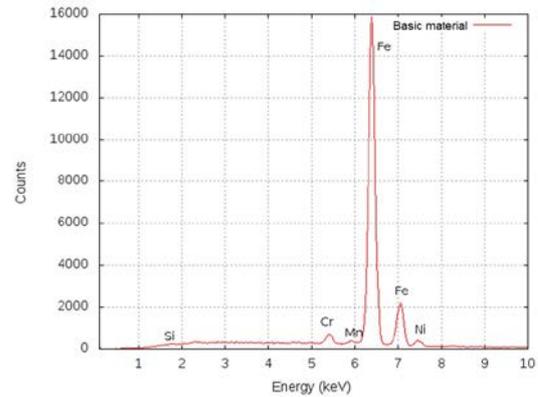
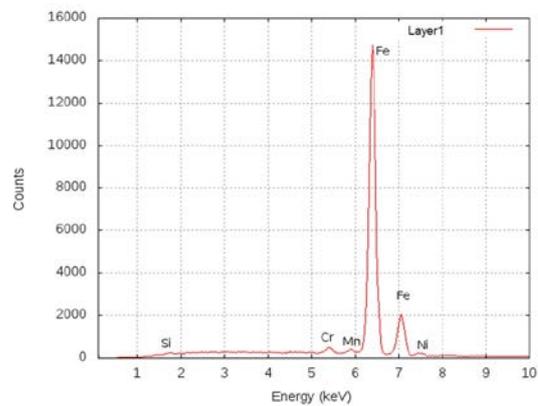
Similarly, analysis of chemical composition was accomplished for surface layer of material of disc that remains a part of rotor (in location of sample B). Chemical composition of basic material and surface layer was realized by EDX analysis. Energy spectra for basic material and for surface layer are given in [Figure 20](#) and

[Figure 21](#), respectively. The spectra are similar and accordingly similar is a presence of chemical elements.
