Shift From Left to a Right Bundle Block on ECG Leading to the Diagnosis of a Malpositioned Lead in the Coronary Sinus: A Case Report

Abstract On electrocardiography (ECG), ventricular pacing appears as a spikes that precede induced QRS complexes. The induced complexes with a right ventricular lead have the morphology of a left bundle branch block (LBBB). We describe a case of malposition right ventricular (RV) lead in the coronary sinus diagnosed based on the changes noted in the ECG tracing. An 80-year-old man with a pacemaker implanted for high-grade AV block was found unresponsive. Six minutes of cardiopulmonary resuscitation resulted in return of spontaneous circulation. The ECG demonstrated a new paced right bundle branch block (RBBB) pattern. Chest radiography revealed a misplaced right ventricular (RV) lead in the coronary sinus which was confirmed by 2D-echocardiography. The patient's healthcare proxy (HCP) declined invasive interventions. The patient expired due multiorgan failure secondary to ventilator associated pneumonia. When an RBBB pattern is seen with RV pacing, patients must be evaluated for mispositioning of the RV lead navigation through an atrial septal defect

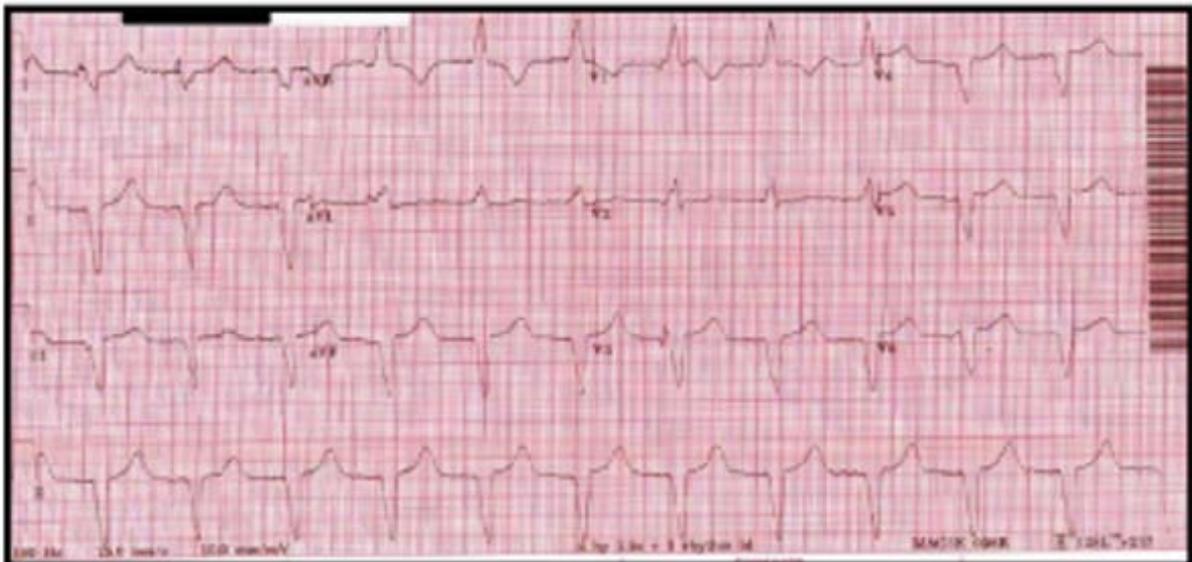
Figure 2. EKG showing RBBB pattern with RV pacing

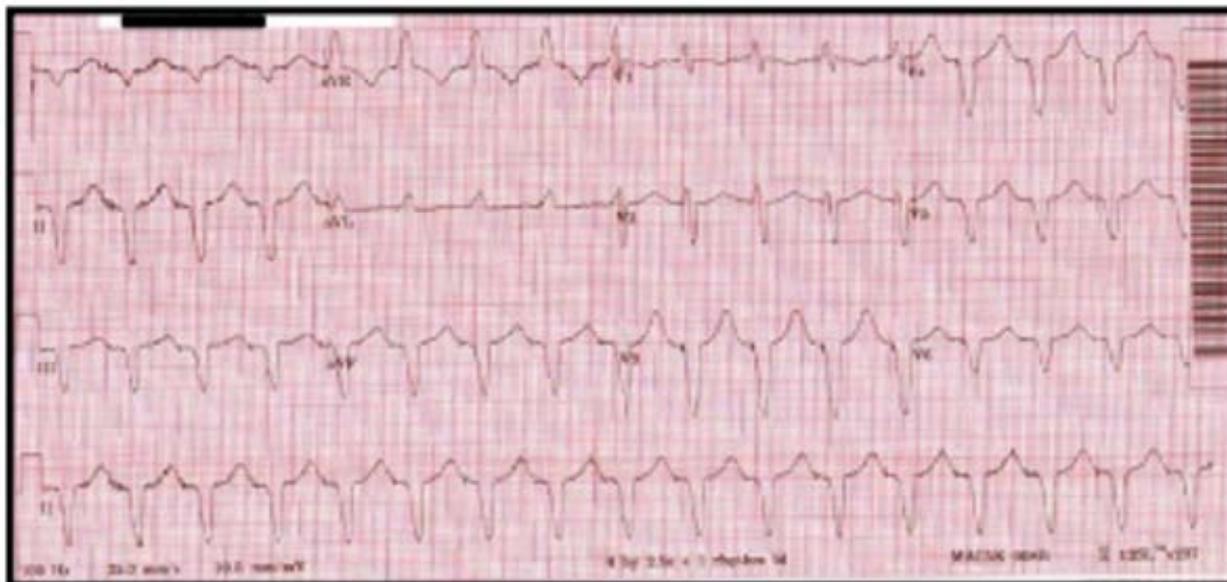
Figure 3. EKG with asynchronous pacing (with magnet on the pacemaker) showing RBBB

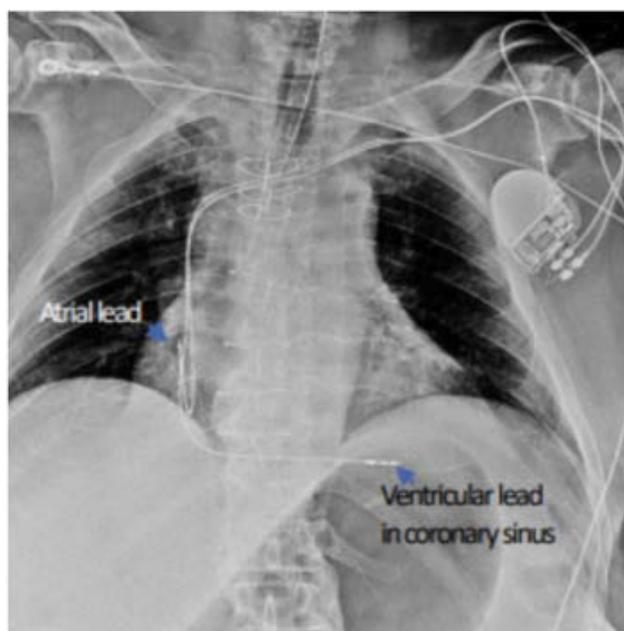
Figure 4. Chest X ray showing mispositioned right ventricular lead in the coronary sinus
