Determining the Contribution of Different Structural Layers of Asphalt Pavement System to Rutting Using Transverse Profile Analysis

Hussan S.^{1,*}, Kamal M. A.¹, Khan M. B.², Irfan M.², Hafeez I.¹

Figure 2. Site layout and testing plan of selected National Highway (N-5) portion

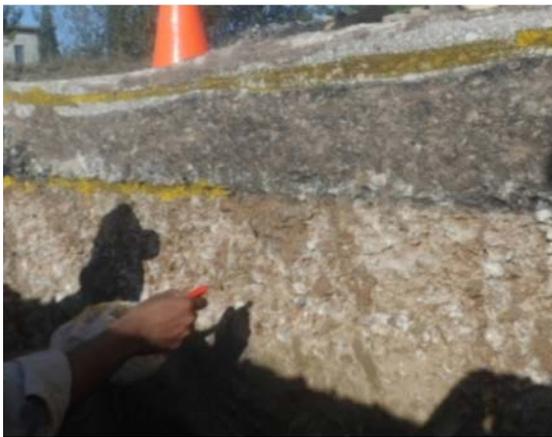
(a) Marking layer boundaries

profile # 01 so that layer can be identified clearly. Next step is to separate boundaries of different layers with the help of yellow paint in order to identify layer variation, Figure 4(a) elaborates it. In the last step wooden straightedge is used as a reference, and layer thickness variations are measured relative to that straightedge. The reading is taken at a transverse spacing of 0.25 m (10 in.). Figure 4(b) elaborates it. The results are then used to draw trench profile which is then compared with results from transverse profile failure analysis.

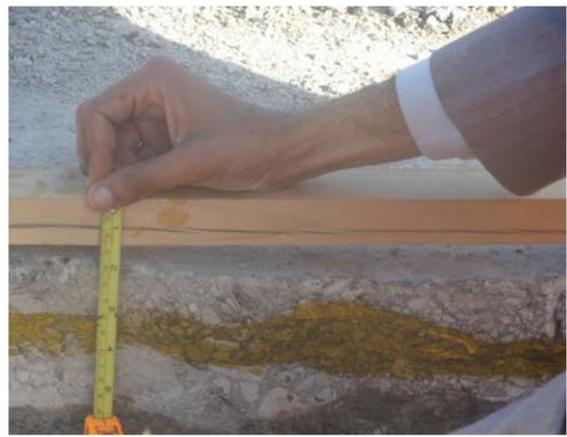
(b) Variation in layer thickness

Figure 4. Measurement of rut depth in each layer by field trenching

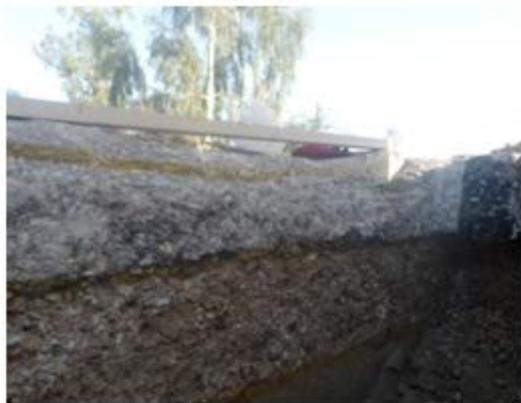
(a) HMA Failure in Left Wheel Path

Our purpose to excavate a trench is to determine layer thickness variation with reference to the straightedge throughout the lane width, layer thicknesses are measured at a spacing of 0.25 m. Figure 5(a) shows the left wheel path in which maximum rut depth is measured. It is

clearly visible from the figure that thickness of HMA is less at the wheel path and increases as we move towards the center. Similarly Figure 5(b) shows the right wheel path. It also indicates the problem in HMA layer but the rut depth is less as compared to that in left wheel path. Figure 5(c) shows the deformation of the underlying layers. It is obvious that subbase and subgrade layers are not deformed to a considerable extent. This shows that these layers are intact. So it becomes certain that Hot Mix Asphalt (HMA) Layer has been failed. This is reconfirmed by drawing a trench profile from layer thickness variations measured at a transverse spacing of 0.25 m, as shown in Figure 5(d).
