Flexural Behavior of Post Tensioned Beams Damaged by Reinforcement Corrosion before and after Applying Patch-Repair

Niloufar Ghazanfari^{1,*}, Amir Manafpour², Mohammad shekarchi³

Cite This Article: Niloufar Ghazanfari, Amir Manafpour, and Mohammad shekarchi, "Flexural Behavior of Post Tensioned Beams Damaged by Reinforcement Corrosion before and after Applying Patch-Repair." *American Journal of Civil Engineering and Architecture*, vol. 4, no. 5 (2016): 171-180. doi: 10.12691/ajcea-4-5-4.

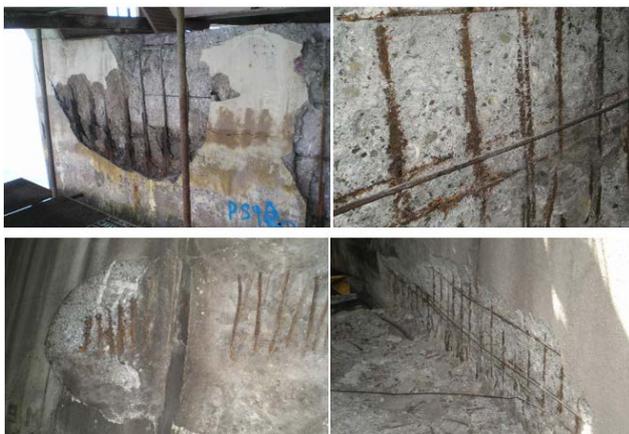
Figure 3. Deterioration of beams and destruction of concrete cover in a structure situated in the Persian Gulf

The aim of constructing and testing beam F3, which is deliberately and manually deteriorated after corrosion, is to consider extreme effect of corrosion (spalling of concrete cover) on the performance of the structure. Based on previous evaluation of structures in Persian Gulf region, in some cases, the concrete cover is completely destroyed and the reinforcement is exposed as shown in Figure 3. In order to create similar conditions in the lab, the concrete cover on beam F3 is completely removed until the reinforcement can be seen.

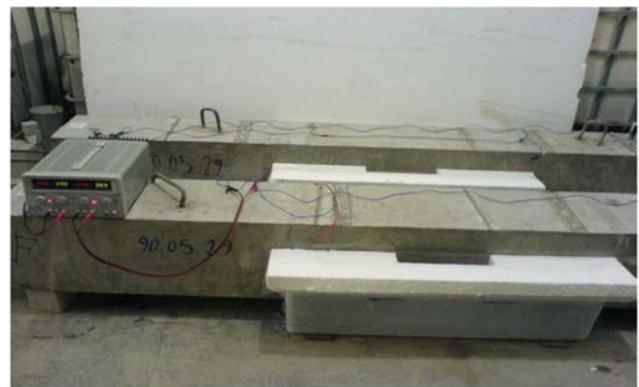
Figure 4. Photo of setup for accelerated corrosion test

An electrolyte corrosion technique was used to accelerate the deformed steel corrosion. The specified portion of beams F2 to F5 were submerged in the 5%

NaCl solution as the electrolyte in a plastic tank. Power supplies with adjustable voltage and direct current of 600 mA were chosen for the electrolyte corrosion process. The positive side was connected to reinforcement cage and the negative voltage was connected to stainless steel plate. The corrosion was limited to the central zone with length, width and height of 85cm, 30cm and 7.5cm, respectively so that the prestressed strands were not corroded. In actual structures under severe corrosion the whole beam would have usually corroded. However, the focus of this study is on the flexural capacity of the beams and so only the middle section (which has maximum moment) of each beam was corroded.

So, the corrosion period for the beams was extended to 75 days. Figure 4 shows a photo of the experimental setup of accelerated corrosion test and Figure 5 shows details of the accelerated setup.

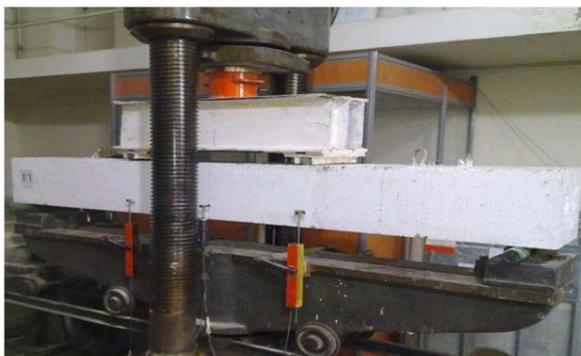
Figure 7. Flexural PT beam test set

PT beams were subjected to a four point flexural testing, 28 days after the application of patch repair. Load was applied in increments by a hydraulic jack and measured with a load cell as shown in Figure 7. Two LVDTs were placed on both sides at the middle of the beams and two LVDTs were used to measure the deflection under the two loading points. The output data was recorded every 3 seconds using a data logger.

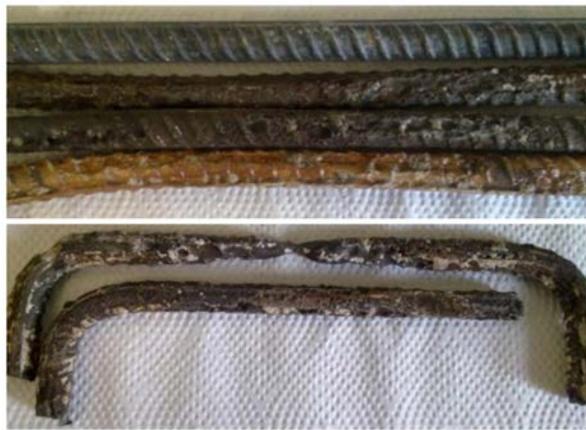
Figure 9. Corroded reinforcement, extracted from specimens after conducting all tests. Top: Longitudinal deformed rebars. Bottom: shear deformed rebars

A 15% degree of corrosion was desired in this study. In order to investigate the exact degree of corrosion, after conducting the flexural tests on PT beams, the corroded rebars were cut and extracted from the corrosion area and then were cleaned as shown in Figure 9.

Exact weight and length of the extracted corroded deformed rebars were measured and the degree of corrosion was determined. Table 6 shows the exact degree of corrosion in the deformed rebars of beams F2 to F5. As seen from the table, the average degree of corrosion for longitudinal and shear reinforcement was 15.37% and 15.75%, respectively. This degree of corrosion is very close to the predicted corrosion from the corrected form of Faraday’s law.

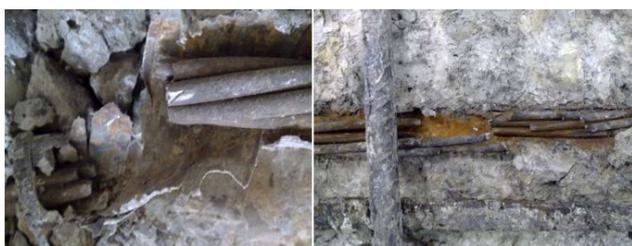
Figure 12. Right: Rupture of strands for F3 beams, Left: Other specimens

Figure 11 shows that there is a change in graph gradient for beam F3 at a load of 15 tons, where the tensile longitudinal rebars have yielded. The rupture mechanism of PT tendons for beam F3 differed from other specimens. In beams F1 and F2 beams the wires within each strand ruptured simultaneously, however the wires of strands in beam F3 ruptured one by one as shown in Figure 12.

Based on Figure 12 to Figure 14 and on closer inspection of the beams, it can be seen that beam F4 (which doesn't use epoxy) has more cracks with smaller widths within the patch repair area in comparison with F5

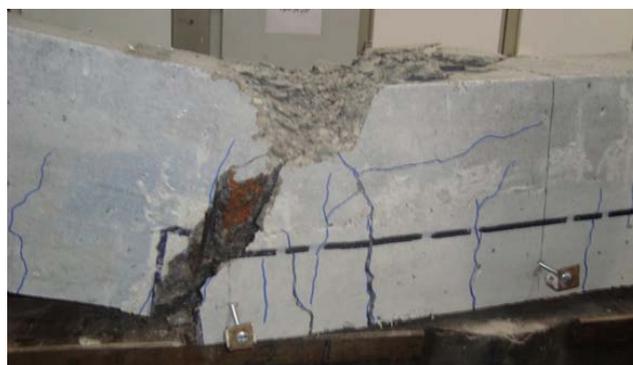
Figure 13. Ultimate cracking and failure of beam F5\

Based on the frequent application of epoxy in repair and rehabilitation projects, it was thought to have a positive effect on the interface between the repair and base section of the beam. The results showed that, not only did epoxy fail to improve the concrete interface, in fact it helped to degrade the interface quality between the repair and substrate concrete. Figure 13 shows that cracking began at this interface in the concrete and after further loading, this part of the concrete completely opened up, and the beam showed shear failure. The results of pull-off tests and Bi-Surface shear test method [23] in this study, have previously confirmed the poor performance of epoxy.

crack at the interface completely opened up after yielding (See Figure 13).

flexural loading tests, there is little difference between the beams with or without using epoxy in terms of flexural capacity. However, the repaired beam F5 that used epoxy, showed large crack width under service loads and shear failure under ultimate loads. Note that the wider cracks under service loads can accelerate the corrosion process in the marine environments.
