Unintentional Slum Creation: Assessing Housing Development in Selected Inner City Settlements of Yenagoa, Nigeria

Abstract This study reveals how the unchecked process of development and city expansion leads to unplanned slum creation in inner city areas of Yenagoa, Nigeria. It explores the relationship between housing development and compliance with building and planning laws in the city. It uses methods like physical observation and case study in examining possible factors that may have contributed to inner city settlements becoming slums. The findings show that factors such as age and maintenance of building, building density, building orientation, and building materials amongst others, have aided in determining the quality of urban environment and ultimately creating slums in Yenagoa, albeit unintentionally.

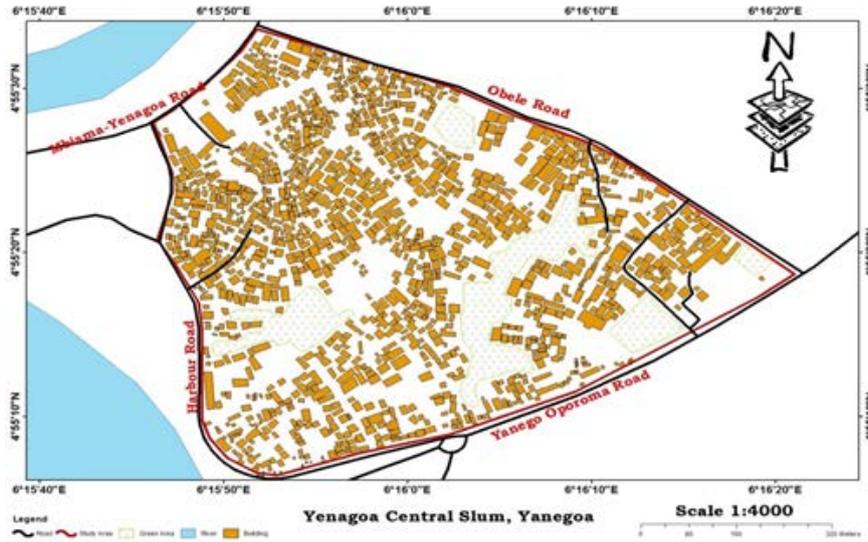
Figure 1. Satellite Imagery of the Study Area showing Yenagoa Central Slum obtained in 2010

The multi-staged sampling technique which involved the listing of all the identified slum locations within the study area, physical enumeration of properties, with the aid of geographic information system map imageries to identify sixty-two (62) streets traversing the entire stretch of the study area. Three (3) slum neighbourhoods were purposely selected for ease of access to collect data on demographic, physical and spatial characteristics of the study area. Systematic sampling technique was adopted to select respondents in the study area. The three slum neighborhoods were purposely identified and captured for the study with the aid of Geographic Information System (GIS) map imageries as shown in [Figure 1](#), [Figure 2](#) and [Figure 3](#) above.

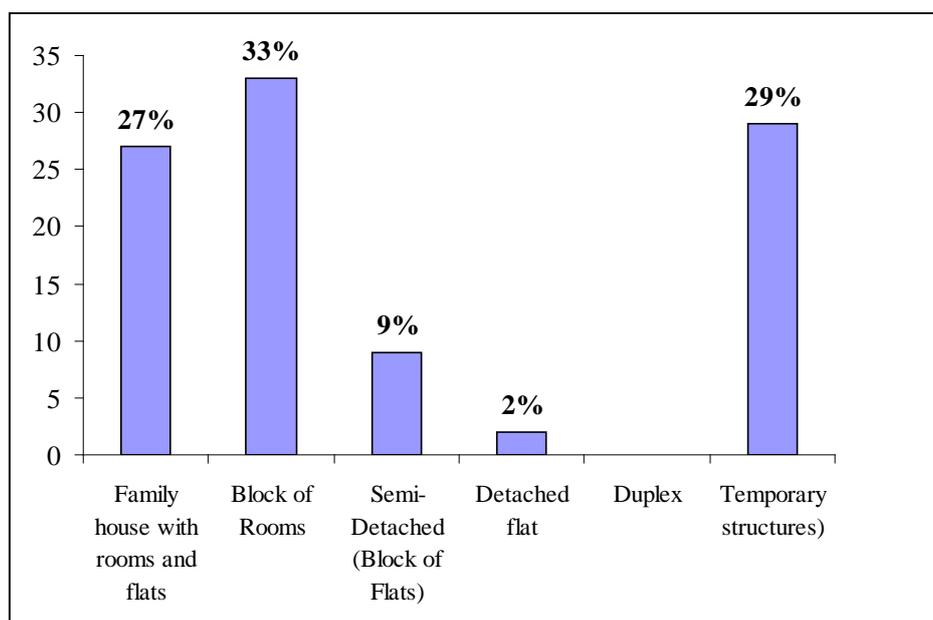
Of the buildings in the study location, the chart below shows the type of houses in the study area. The results show that 27% of the houses in the area are family houses with many rooms and flats, 33% are block of rooms, 9% are semi-detached flats, 2% are detached flats, while 29% are temporary structures. It shows that the types of houses in the area are mainly family houses with many rooms and flats, block of rooms, and temporary structures. This implies that the area is made up of mainly rooming houses which are built to accommodate many households (tenants) in a building with common facilities or without any facility.

Figure 4. Types of Houses

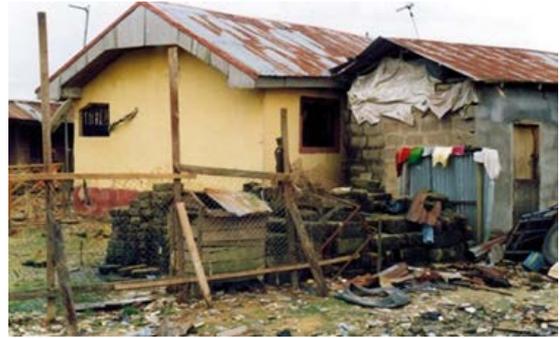
Figure 7. Poor spacing and orientation of buildings at Obele community

The orientation (Positioning) of buildings is another significant parameter for determining the informality of a settlement. The present state of houses in terms of building orientation in Yenagoa is very poor. It is clearly shown that most houses in the study area are poorly positioned with most of them facing the back or sides of other houses without adequate air space. In a well-planned settlement, the building pattern is regulated in a manner that houses either face each other or face the back or sides of other houses with adequate space (setback) or separated by concrete block wall fence. The findings of the study have shown that poor orientation of buildings is also a major factor responsible for environmental problems in Yenagoa. Density in relation to urban planning does not only refer to the number of houses in an area but also persons per unit of space. The findings of the study have shown that high building density in Yenagoa contributes to the creation of informal settlements.

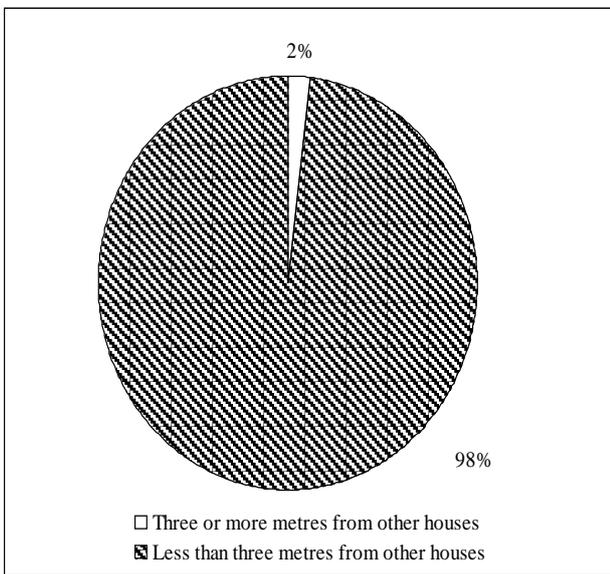
The pie chart shown in [Figure 5](#) below reveals density and the distance between houses in the study area. The results on the figure show that only 2% of the houses in the area are three or more metres away from other houses while 98% are less than three metres apart from other houses. The study further shows that the houses that are three or more metres apart are in Igugu community, while the rest of the houses that are less than three metres apart are in all the three communities in the study area. This shows that houses in the area are overcrowded due to haphazard building operations without adequate air spaces between them. Despite the existing laws to regulate building operations in Yenagoa, developers in the area build houses without adequate setbacks or open space for ventilation and outdoor activities which is a serious environmental challenge [\[16\]](#).

Figure 5. Pie chart showing Building Density (Source: Field work)

The findings of the study show that houses in the area were built without regard for building regulations. The study shows that only 2% of the houses are more than three metres apart while the rest 98% are less than three metres from each other. This has shown that the area is overcrowded with houses. The study further shows that none of the houses in the area is five or more metres from the utility line, only 9% are less than five metres from the utility line, while the rest 91% are built within the utility line. This indicates that property owners in the area have not to comply with the government approved three metres minimum setback between houses and five metres minimum building line (setback) from the utility line. According to [17], the Building Regulations of Nigeria stipulate that no person shall build or erect any dwelling house so that the area covered by the building together with that of all out-houses appertaining thereto shall exceed one half (i.e. 50%) of the total area of the site. The [18] defined Building Line as the line established by law, beyond which a building shall not extend, except as specifically provided by law. With the data presented, there is an indication of a high level of non-compliance with building regulations in the study locations. The implication is that there is high building density, which poses a serious environmental challenge in Yenagoa as the city is overcrowded with houses covering more than 50% of individual plots. The residents of the city lack adequate ventilation not only inside the houses but also within the yards.

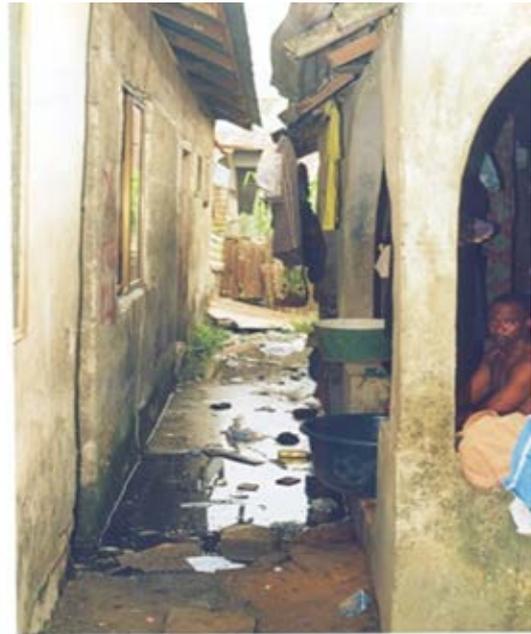
Figure 8. Poor spacing and orientation between buildings

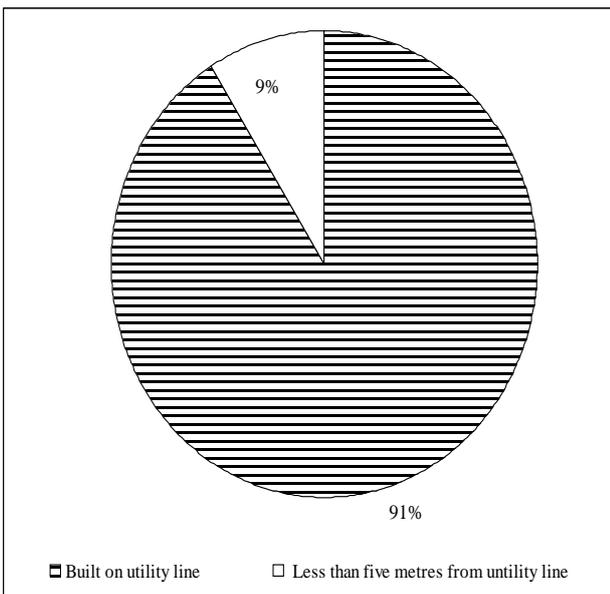
Figure 6. Building orientation and setbacks (Source: Field work)

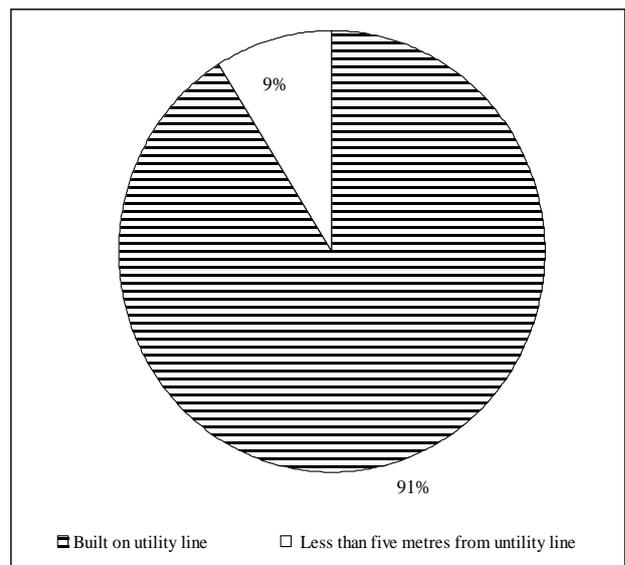
Figure 9. Distance between Houses and Utility Line (Source: fieldwork)

The study further shows that none of the houses in the study area is five or more metres from the utility line, 9% are less than five metres from the utility line, while the

rest 91% of the houses are built on the utility line. It shows that none of the property owners in the area met the government approved building line standard of a minimum of five metres away from the utility line. This is regardless of the fact that majority of the residents living in finished block houses submitted building plans for approval and part of the documentation required for approval is a proposed site plan indicating planning regulation setbacks from the main access, utility lines and oil pipeline right of way. This infers that there is either inadequate land space between houses in the study area and the utility lines or the prescribed setbacks have been ignored.
