# Auto-Deploying Vertical Band Saw Guard

Ralph L. Barnett\*

Mechanical and Aerospace Engineering, Triodyne Inc. 3054 N. Lake Terrace Glenview, IL

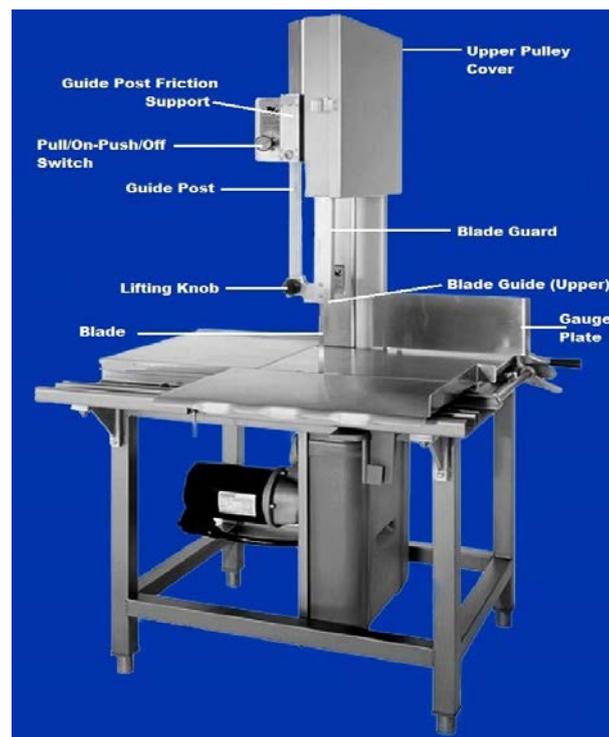
Figure 1. Typical Meat-Cutting Vertical Band Saw

The original design of the Hobart Model 6614 meat saw shown in Figure 1 uses a one-piece prismatic blade guard with an angle section; one leg is outboard and the other is in front of the blade teeth. The bottom of the blade guard is rigidly attached to a guide post with a manual lifting knob that allows the height of the guide post/blade guard to be “friction set” at a desired blade exposure. Within the confines of the guide post and blade guard, a blade guide (upper) is located that supports and stabilizes the band saw blade. There is a lower blade guide just below the table top.

- G. Imprinting a scale on the gauge plate shown in Figure 1 enables the operator to measure the height of the work product and set the retrofit clamp accordingly. For example, if the height of the work piece is measured at 3- 1/2 inches the retrofit clamp would be set at 3-1/2 plus 1/4 inch below the guide post support when the guide post is sitting on the table top.

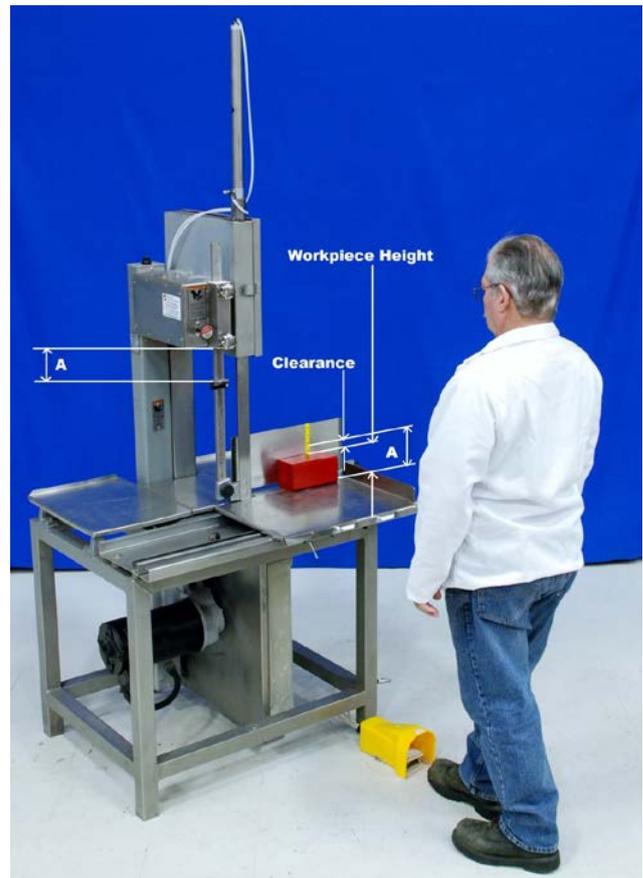
**Figure 2.** Retrofit Meat Saw With Foot Pedal Released— Workpiece height plus clearance = A; Clamp setting = A; Guard touches table top

A retrofit meat saw is depicted in Figure 2 with the entire “point-of-operation” portion of the band saw blade enclosed. The following components have been retrofitted:

1. Retrofit Guide Post - The original guide post has been perforated with 1/4-inch diameter holes drilled on one - inch centers. The holes are not as important as the one - inch delineation which could be etched into the guide post.
2. Retrofit Clamp - The fabricated clamp illustrated in Figure 2 may be held in place on the guide post

using the holes for an interference fit. Between holes, the clamp is secured by friction. The distance between the top of the clamp and the bottom of the guide post friction support defines the selected blade exposure (see Figure 2 and Figure 3).

6. Retrofit Foot Valve - The yellow foot valve illustrated in Figure 2 causes the guide post/blade guard to raise or lower respectively when the pedal is depressed or released. In its lowered position, the blade guard fully encloses the blade.

- Step 2. Use a low clamping force on the guide post (loosen front knobs).
- Step 3. Set the mode selector switch to “Air Only” [See Figure 7].
- Step 4. Preset the clamp elevation to provide the smallest usable blade exposure or “point-of-operation.”
- Step 5. The saw motor switch may be on or off (Pull to Start, Push to Stop).
- Step 6. Step on foot valve pedal to raise the guard and expose the “point-of-operation;” see Figure 3.
- Step 7. Release the foot valve pedal to enclose the band saw blade entirely “when finished with a cut” or “between cuts;” see Figure 2.

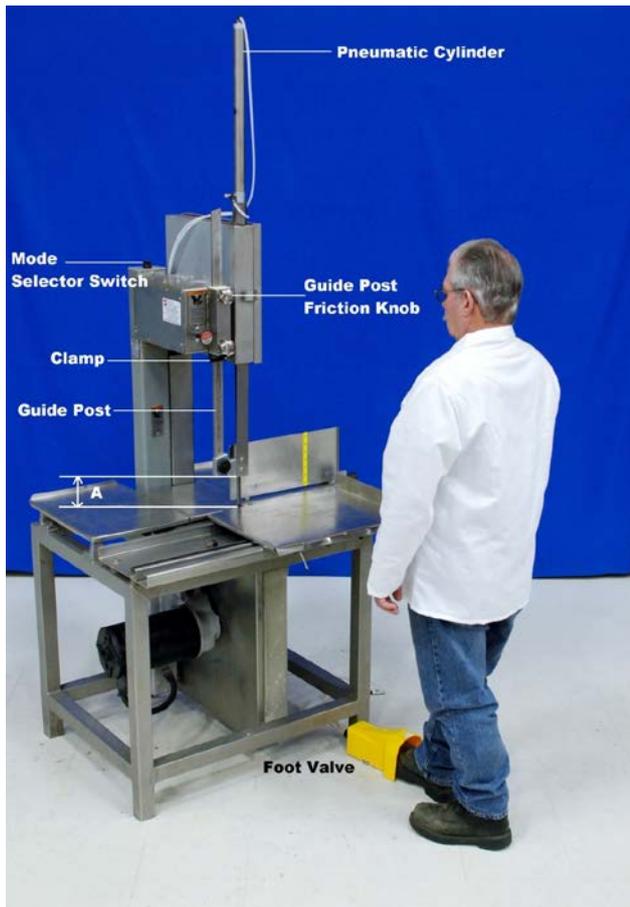
**Figure 3.** Retrofit Meat Saw with Depressed Foot Pedal— Pneumatic cylinder exposes blade height = A

4. Retrofit Pneumatic Cylinder - A two-way pneumatic cylinder with a 1.25 inch I.D. is mounted directly above the blade guard shown in Figure 3. A mounting bracket was constructed.

7. Retrofit Selector Switch - Figure 3 and Figure 7 reveal a mode selector switch mounted on top of the band saw column. Two of three operating modes are delineated with this control.

- F. The guide post may be marked to reveal the exact elevation of the guard. When the guide post and blade guard are fully lowered to the table top, the distance between the top of the clamp and the bottom of the guide post support or guide post bracket is exactly the same as the point-of-operation or fully exposed band saw blade, see Figure 2 and Figure 3. The guide post should be scribed on one-inch centers or delineated with drill holes such as shown in Figure 3.

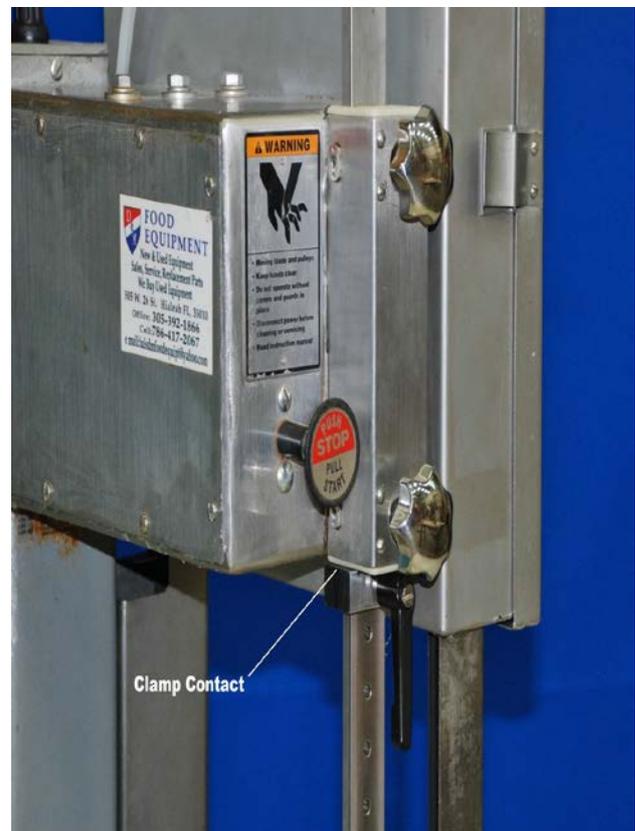
**Figure 4.** Retrofit Controls: Push Stop/Pull Start, Two Friction Knobs, Clamp

3. Retrofit Knobs - Figure 4 illustrates two knobs on the front of the guide post friction support that have been substituted for the original hole plugs and hidden set screws. They are loosened to eliminate the original counterweight effect.

Step 3. In accordance with the original operating instructions (Hobart, Slide Bar Adjustment, Form 34527 Rev. B, August 2011), counter balance the guide post/blade guard using the two retrofit handles on the front of guide post friction support, Figure 4, together with the two set screws on the side.

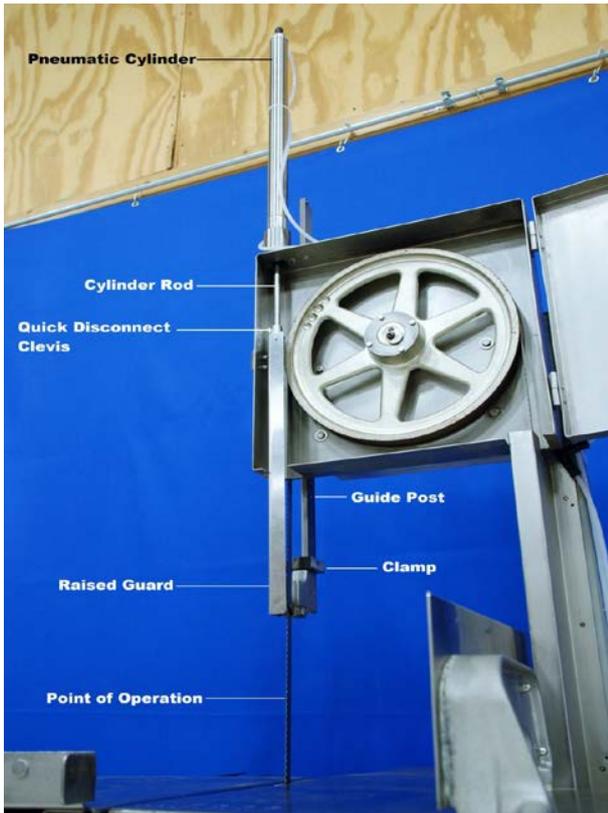
Figure 5. The Linkage: Cylinder, Cylinder Rod, Quick Disconnect Clevis, L-Shaped Guard, Guide Post, Clamp, Blade

5. Retrofit Quick Disconnect Clevis - An Easy Adapt Clevis Rod End joins the cylinder rod to the top of the blade guard so the guard may be quickly removed without tools for cleaning (Figure 6). The sheet metal on the bottom of the upper pulley cover required trimming to accommodate the clevis.

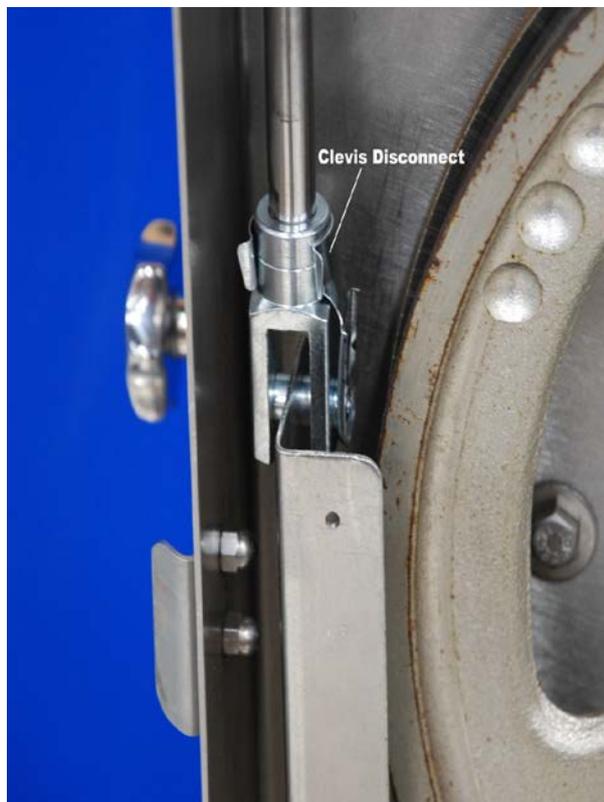
Figure 6. Quick Disconnect Clevis

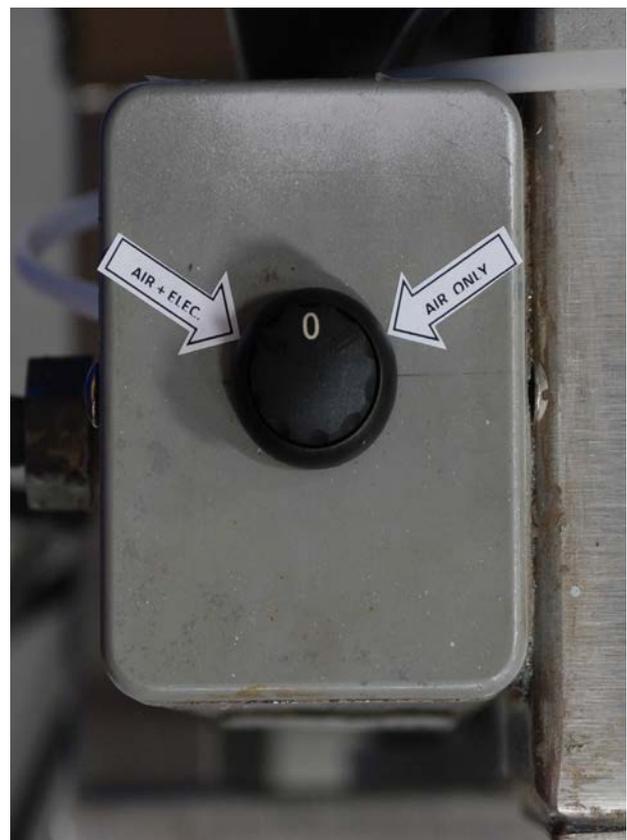
Figure 7. Mode Selector Switch

The mode selector switch was labeled “Air Only” for the independent operation of the guard; it was labeled “Air + Electric” for the simultaneous operation of guard deployment and saw motor control (Figure 7). During the long rundown of the band saw blade (14 sec.), the blade is completely enclosed. Our exemplar meat saw was not equipped with a brake. A brake can stop a blade in a fraction of a second.

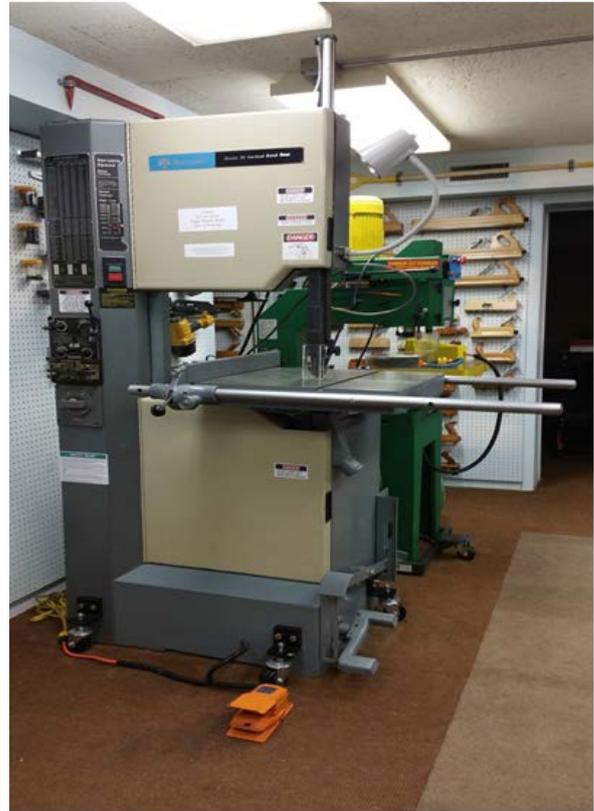
Figure 8. Rockwell 20" Metal-Wood Vertical Band Saw

The Rockwell 20 "Metal-Wood Variable Speed Band Saw shown in Figure 8 was retrofitted with a pneumatic/electric guard system. The band saw, Model

No. 28-345, was manufactured in 1980 and provided a speed range from 4500 to 50 ft/min. This general purpose machine accommodates a large variety of band saw blades that are protected with a telescoping blade guard.

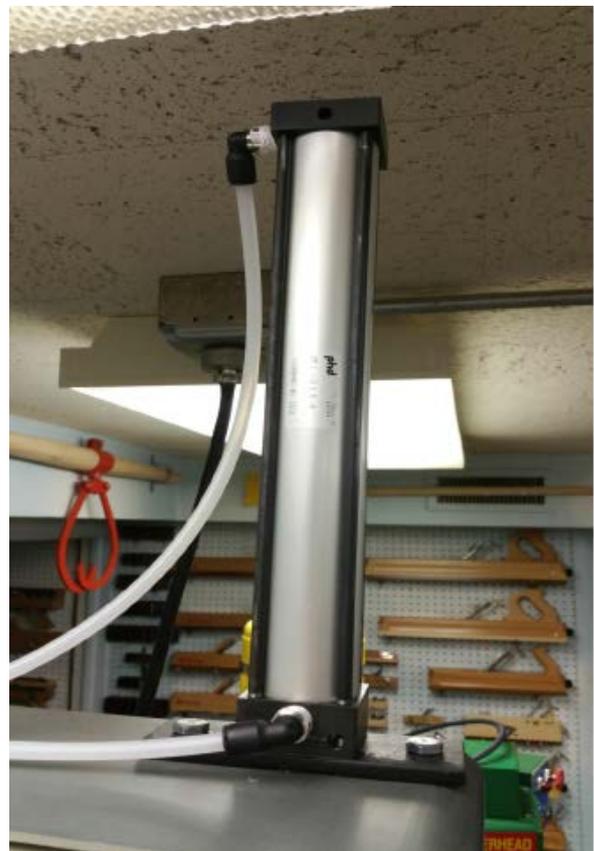
Figure 9. Two-Way Pneumatic Cylinder

1. Retrofit Pneumatic Cylinder - In contrast to the meat saw, a pneumatic cylinder was attached to the guide post instead of the telescoping guard. Because the guide post and the blade guard are rigidly fastened at their lower ends, lifting the guide post raises the guard. [Figure 9](#) depicts the two-way cylinder.
2. Retrofit Clamp - To control the elevation of the guard, a clamp was fabricated to grip the guide post

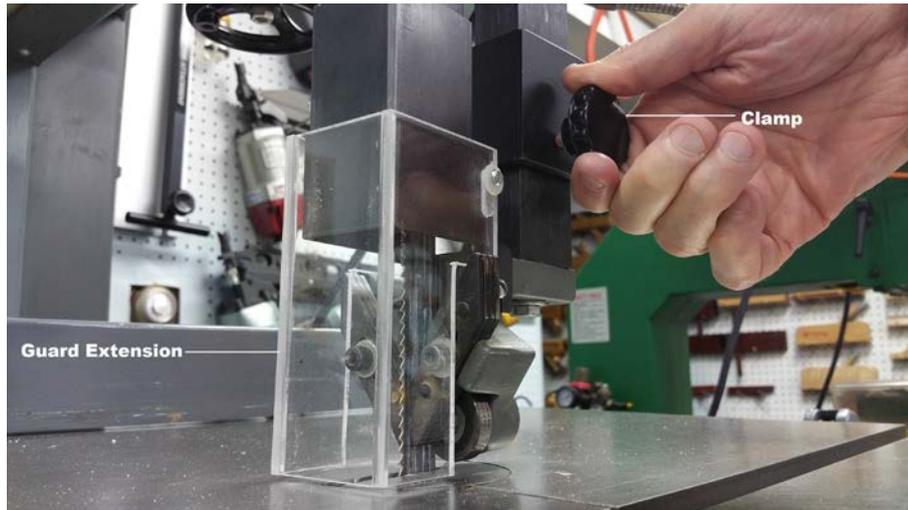
**Figure 10.** Retrofit Clamp on Guide Post; Retrofit Transparent Guard Extension

as illustrated in [Figure 10](#). The vertical travel of the guide post is limited when the clamp contacts the bottom of the guide post bracket as depicted in [Figure 11](#).

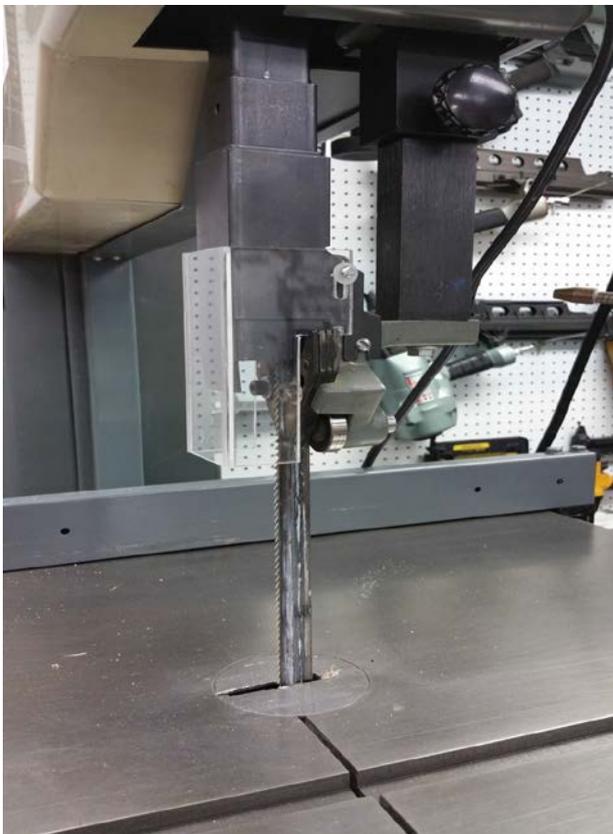
**Figure 11.** Contact Between the Clamp and the Bottom of the Guide Post Support Bracket

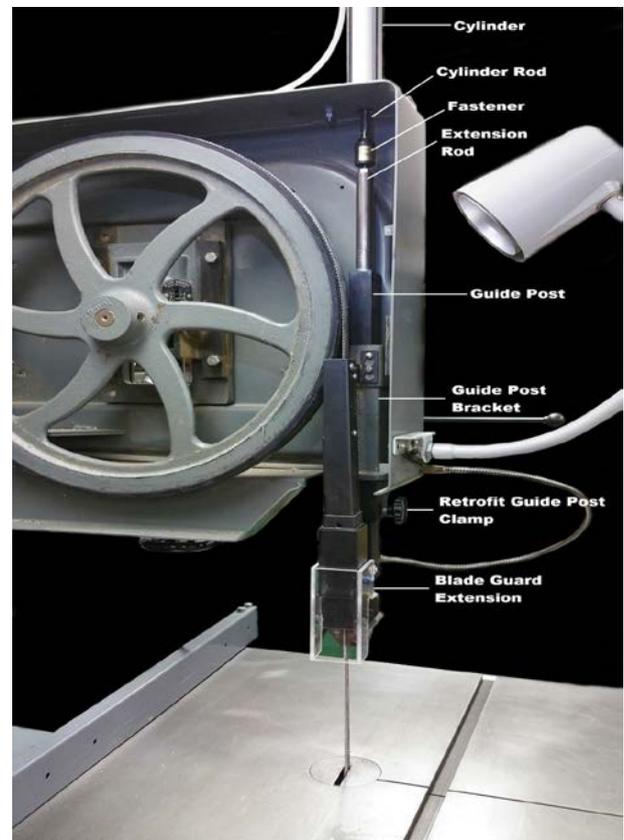
**Figure 12.** The Linkage: Cylinder, Cylinder Rod, Fastener, Extension Rod, Guide Post, Guide Post Bracket, and Retrofit Clamp

3. Retrofit Cylinder Rod/Guide Post Fastener - [Figure 12](#) illustrates the lifting linkage used to elevate the solid square guide post. An extension rod is screwed into the top of the guide post, which in turn is screwed into a fastener that joins it to the cylinder rod. The entire guide post bracket is shown in contact with the retrofit clamp.
4. Retrofit Foot Switch - [Figure 8](#) portrays an orange electric foot switch that controls the raising

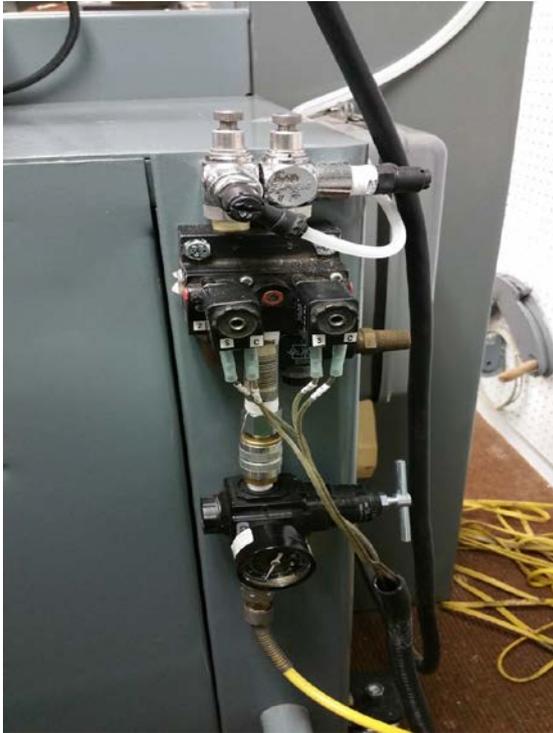
**Figure 13.** Solenoid Valve

5. Retrofit Solenoid Valve -To control the pneumatic cylinder, the foot switch sends an electric signal to a solenoid valve that appropriately directs air to the cylinder. Because the meat saw's guard control system was entirely pneumatic it did not use a solenoid valve; only the foot valve was required to control the cylinder. The solenoid valve, which is shown in [Figure 13](#), has the capability of adjusting the air flow. This is an unnecessary feature for a production machine.
6. Retrofit Guard Extension -The original guard extension was opaque. The retrofit transparent blade guard extension depicted in [Figure 10](#) improved the ability to cut along a scribed line on the workpiece.

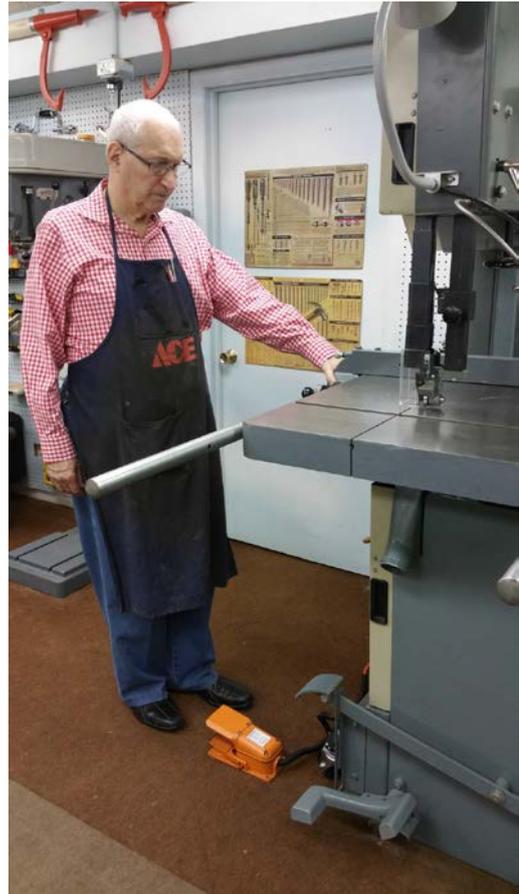
**Figure 14.** Fully Guarded Band Saw Blade, Pedal is not Depressed

[Figure 14](#) illustrates the fully guarded band saw blade when the foot switch pedal is not depressed. When the operator steps on the pedal as depicted in [Figure 15](#), the guard is raised to an elevation defined by the clamp position. This exposes the “point-of-operation” so a workpiece can be cut. Walking away from the band saw leaves the blade fully protected when the machine is either stationary or in motion.

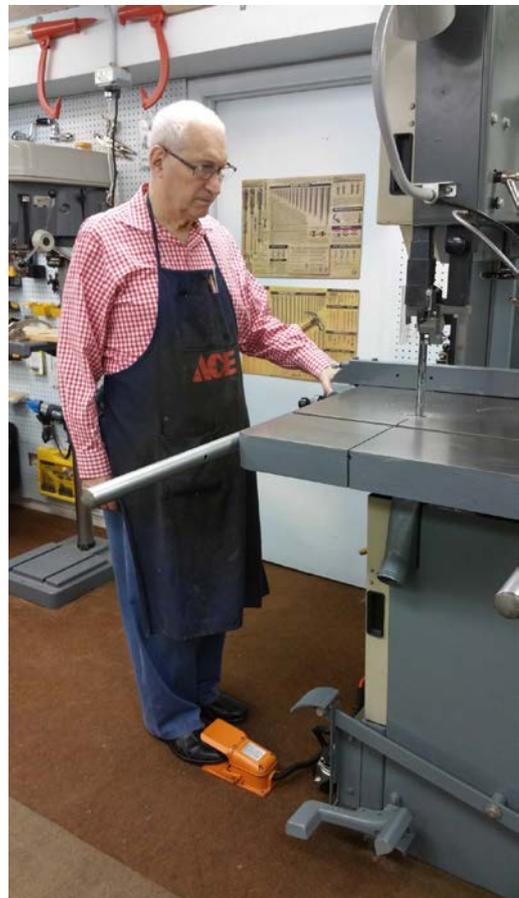
**Figure 15.** Exposed Band Saw Blade for Cutting

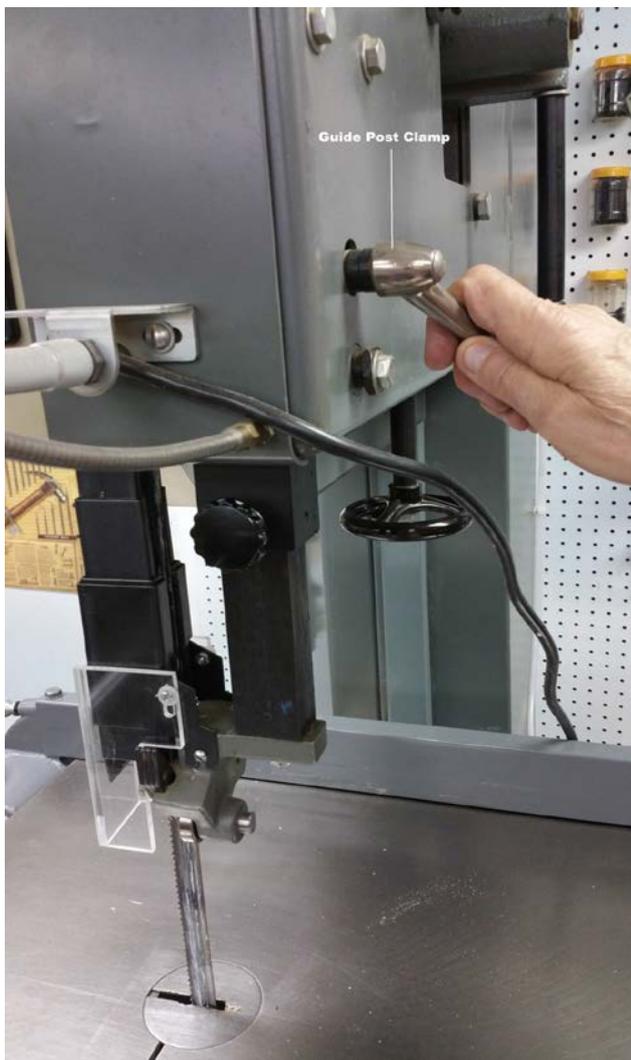
Figure 16. Original Guide Post Clamp

Having recaptured the original control system, use only the original guide post clamp to set the blade exposure, [Figure 16](#).
