Repair of Accidentally Perforated Labial Wall of a Central Incisor Having Failed Root Treatment – A Case Report

Abstract This is a successfully managed clinical case report of a young lady whose tooth # 11 was root treated in 2010 which reinfected after three years. The root treatment was repeated but was iatrogenically perforated because of the operating dentist's error. The tooth was therefore opened for surgical correction. During the procedure, it was found that labial wall of the tooth was missing in the mid-root area. The labial wall was built using glass ionomer cement keeping the endodontic file in the canal to avoid obliteration of canal space by glass ionomer. The rebuilt canal was treated with Calcium Hydroxide dressings at an interval of 7 days. In two weeks as the sinus healed, swelling subsided and the canal became effortlessly dryable using just two absorbent points, the canal was obturated with a custom made gutta percha cone, employing glass ionomer as a canal sealer.

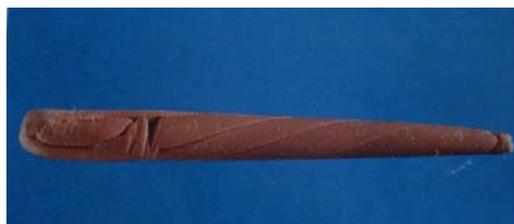
Figure 5. Custom made GP cone

length. Once the glass ionomer set hard, the file was retrieved gently as patency of the canal was thus maintained. Using any condensation pressure during obturation would have been detrimental. The newly built labial wall might have crumbled under the condensation force. This problem was resolved with the use of a custom made GP cone prepared while the canal was open, easily accessible and visible with the naked eye. The slightly loose fit cone when loaded with GIC based sealer fitted well inside the canal.

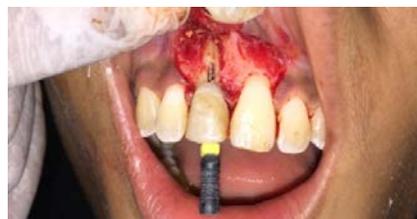
Figure 6. Extensive loss of labial wall showing inserted file

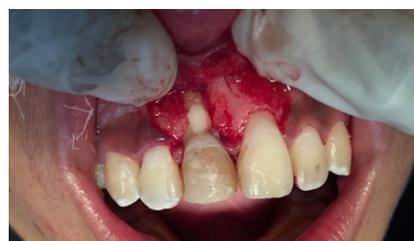
Figure 7. Wall fabricated using GIC
