The Role of Human Activities in Streambank Stability: Lower Sakarya River (NW Turkey)

Cite This Article: Umit Duru, "The Role of Human Activities in Streambank Stability: Lower Sakarya River (NW Turkey)." *Journal of Geosciences and Geomatics*, vol. 5, no. 3 (2017): 130-135. doi: 10.12691/jgg-5-3-4.

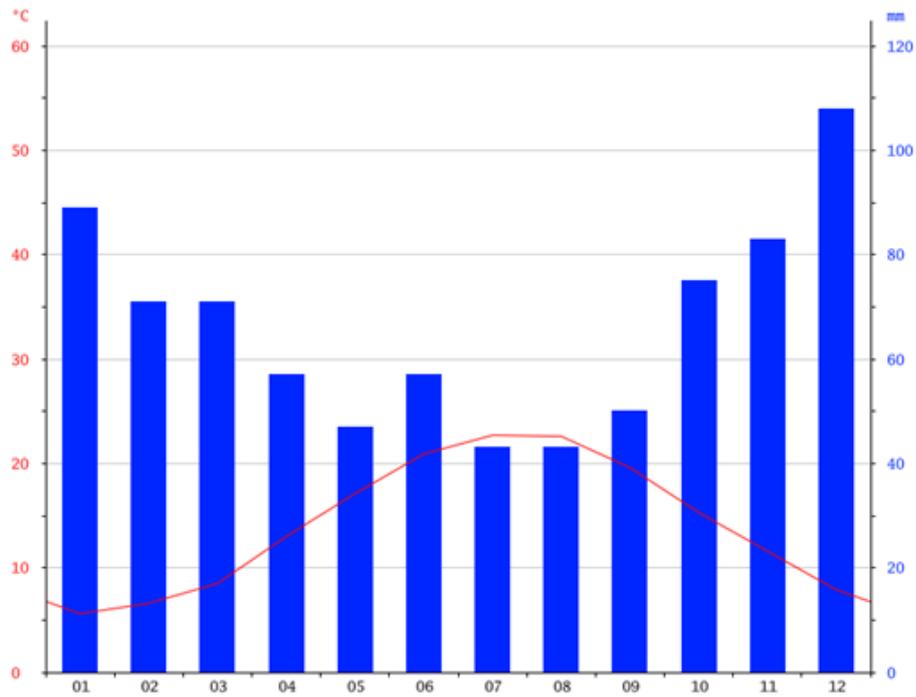
Figure 2. Monthly precipitation and mean temperature at Adapazari Meteorology Station

54.000 km², which is the third largest basin in Turkey. The study area, a length of 8.1 km and 200 m wide each side, is situated between D-100 highway to Historical Sakarya Bridge, east of the Sakarya province. The mean annual precipitation in the region is 795 mm, the most of the precipitation falls during Winter (32,6 %); the lowest precipitation rate seen in the summer (19,7 %) (Figure 2). The region experiences semi-humid characteristics.

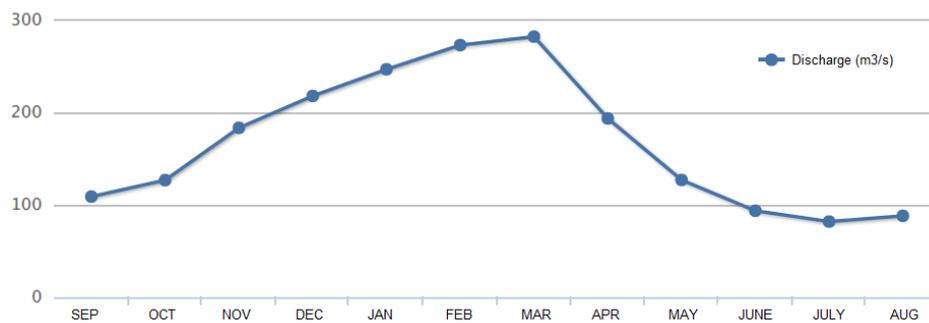
Figure 3. The mean annual discharge is observed at Botbasi gaging station (1960 – 2002)

The study area lies on alluvial deposits formed late Pliocene – Quaternary with gentle slopes. Cohesionless sand formation is the most dominant in the streambanks, so streambank erosion occurs with lower stream discharge due to lower bed shear stress for sediment transport. The mean annual discharge of 250 m³/s is observed at Botbasi gaging station (Figure 3). In the region, 3 ongoing instream mining operations, 2 out of order mining operations, 1 dam construction and 2 bridges leave significant fingerprints riverine environment. Moreover, an ongoing project respecting river restoration (e.g. concrete armoring of streambank, diversions of river) was recently started in the region. The western portions of the Sakarya River have a higher population density (Table 1).

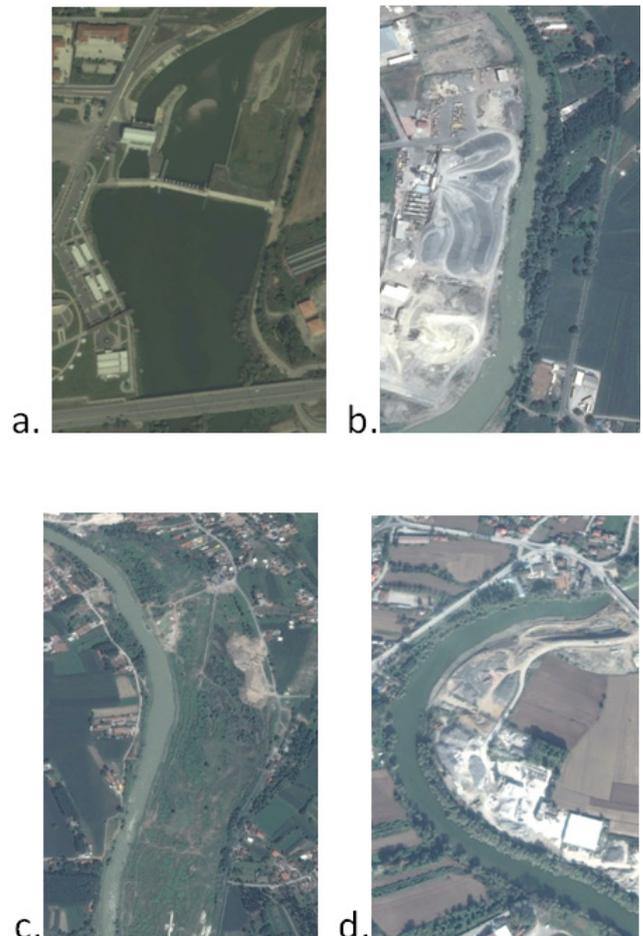
Figure 4. Photograph shows anthropogenic impacts of the study area, (a) Sakarya HES Dam; (b) Instream sand mining operation; (c) Unserviceable instream mining operation; (d) The Historic Sakarya Bridge crossing Sakarya River

Adasu hydroelectric power station (HES) was constructed in the year of 2010 (Figure 4a). The power station not only caused a reduction of channel flow, but more importantly flow regimes. The power dam also reduces stream velocity caused decreased in stream power, and the river is transport limited after its operation. After the Adasu HES operation more steady stream characters were observed due to primarily reduced flood frequency, water velocity, stream power, shear stress on sediment particles deposition along the streambank. Fluvial processes cannot be developed at low discharge of water. Despite variation in channel characteristics may occur, the implementation of a dam does not always cause geomorphic changes [3]. After the HES construction even 3 km downstream portion of the dam had experienced narrowing channel width and expanding mid-channel bars. A reduction in flood magnitude resulting from dam construction has been previously proposed by [17]. Reference [18] reported that flow reduction can promote vegetation establishment in pre-dam channel, which can accelerate the rate of channel narrowing.

Figure 4c illustrates disused instream mining places along the outside of the bend. There are numerous pits captured surface water and create their own environment in the past decades. Out of service instream mining area, 1 km upstream of the Historic Sakarya Bridge, has recently been used for storing debris removed from the arches of the historical bridge. In fact, surface runoff will eventually transport the stored debris to the stream network, accordingly sediment particles will be temporally deposited at the places later on.

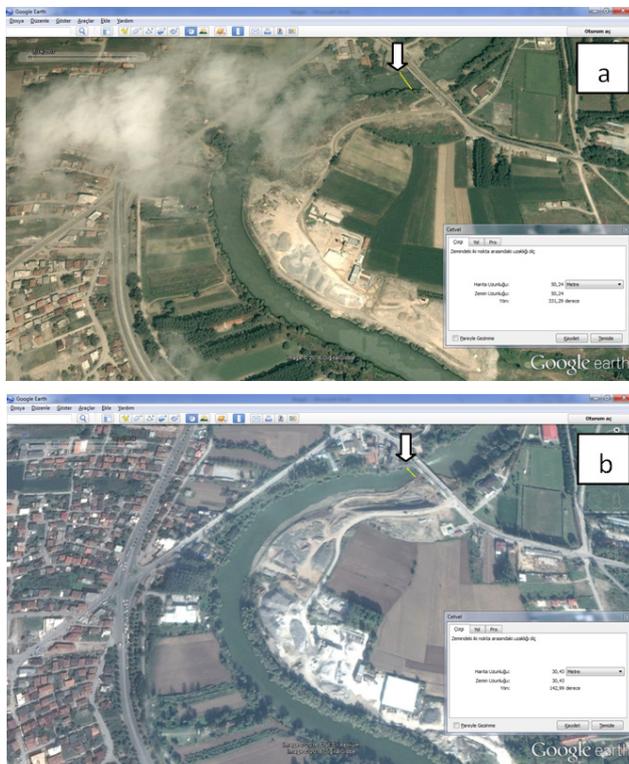
Figure 5. A photograph represents the Sakarya River narrowing process at Historic Sakarya Bridge: (a) Google Earth view in 2003, (b) Google Earth view in 2016

Additionally bridge contractions caused local scouring as well as sediment accumulation subject to back water effect. Bridge piers reduce velocity of water correspondingly stream power for sediment transport. Recently two arches of the historic bridge were filled with sediment at the downstream course of the study area. From 2003 to 2016, the width of the stream at the Historic Sakarya Bridge has reduced ~ 20 m, so the stream flows through the bridge using only one arch (Figure 5).

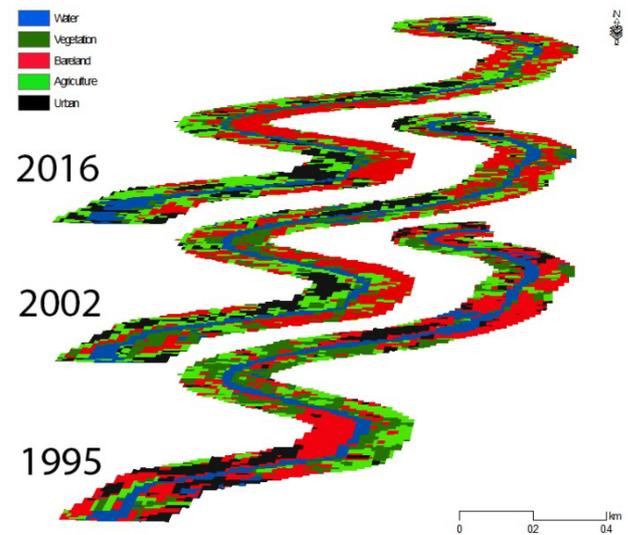
Figure 6. Land use/cover change along Sakarya River (1995 – 2016)

In the last two decades due to extensive changes in LULC along the river, stream bank erosion rate has been increased (Figure 6). Population growth in the research area is significant in the past 2 decades, resulting expanding industrial as well as other anthropogenic activities around the stream channel. Change in land use type from agriculture to industrial usage has disturbed nature of channel dynamics. From satellite images, anthropogenic activities in the buffered zone has been increased as a result of construction infrastructures, settlements and industrial operations, so the channel mainly displaced toward east ranging from 2.9 to 36 m 1995 and 2016, respectively due to higher amount human activities on the western course of the river. Population growth in the region in the past 21 years is associated with
