Investigation of Weld Defects in Similar and Dissimilar Friction Stir Welded Joints of Aluminium Alloys of AA7075 and AA6061 by X-ray Radiography

Abstract X-ray radiography techniques are used for evaluation of the quality of the friction stir welded aluminium butt joints. This paper reports X-ray radiography testing conducted on similar friction stir welds between AA7075T₆₅₁ aluminium alloy and dissimilar friction stir welds between aluminium alloys AA7075T₆₅₁ and AA6061T₆. The Friction stir welds of AA7075 & AA6061 aluminium alloy were produced at different tool rotational speeds and transverse speed. The tool rotational speed was varied from 800, 900, 1000 rpm while the transverse speed was varied from 30, 35, 40mm/min. The visual inspection and the x-ray radiographic testing techniques were employed to conduct the tests; these tests were conducted on the welds to ascertain the joint integrity before characterization to have an idea of the quality of the welds. In visual defects, the lateral flash was observed in most of the welds, but the x-ray radiography technique revealed the presence of lack of penetrations flaws in all weld samples and cracks, voids, wormhole defects in s

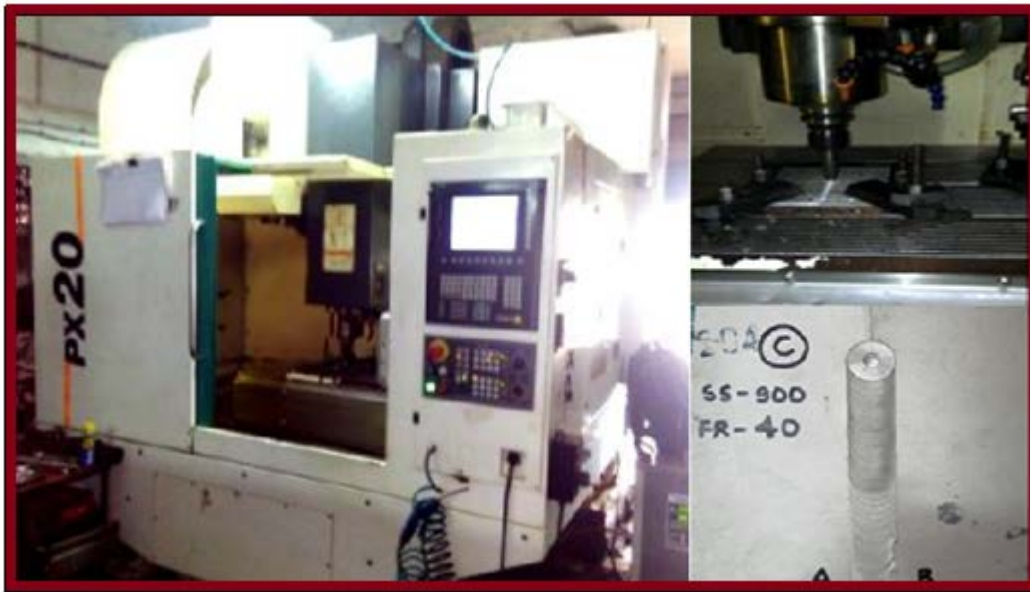
Figure 1. Friction stir welding on VMC machine with FSW joint

mm/min, 35 mm/min and 40 mm/min. The tool tilt was maintained 0° during the experiment and plunge depth was of 6mm throughout the weld path. Tool tip plunge feed 10 mm/min throughout the weld path. The plates to be welded by FSW process are fixed by a clamping fixture on a Joyti CNC vertical machining center PX20 series as shown in Figure 1. The initial joint configuration was obtained by securing the plates in position using mechanical clamps. The direction of welding was normal to the rolling direction. Single pass welding procedure was used to fabricate the FSW joint.

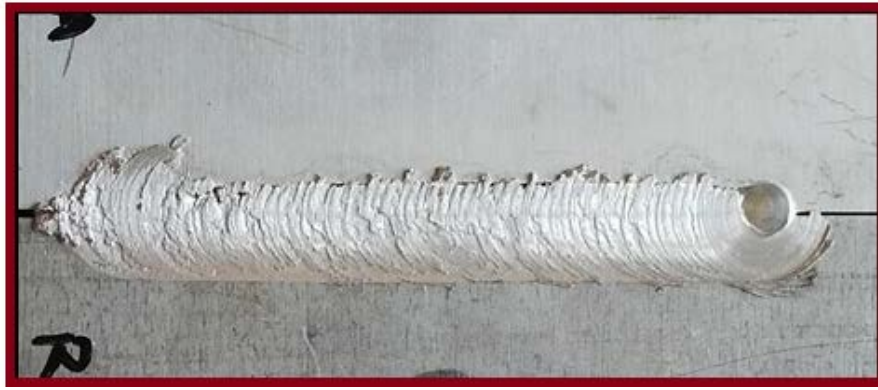
Figure 2. Lateral flash in the joint FSW-A2

Perhaps the most straight forward and simplest inspection technique, visual inspection is an excellent means of inspecting for surface features including excess flash, galling, shoulder voids, and even weld misalignment. Visual inspection was performed on all welded samples in order to verify the presence of possible macroscopic external defects, such as surface irregularities, excessive flash, and surface-open tunnels. The lateral flash was observed in most of the welds, resulting from the outflow of the plasticized material from underneath of the shoulder. Figure 2 shows an example of joint with lateral flash.

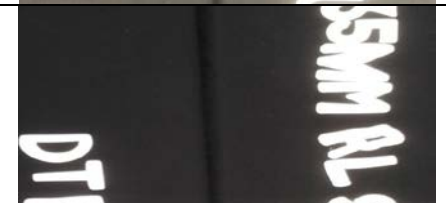
35mm/min	Lack of penetrations, crack, incomplete fusion
I

produced at a constant rotational speed of 800 & 1000 rpm respectively at varying transverse speed of 30, 35 and 40 mm/min has evidence of lack of penetrations, wormhole defect, incomplete fusion, cracks, discontinuity at the joint interface.

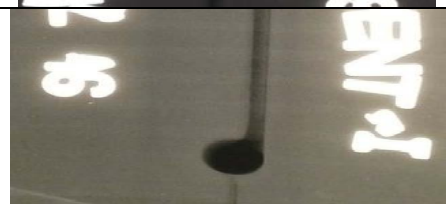
40mm/min	Lack of penetrations, hole left

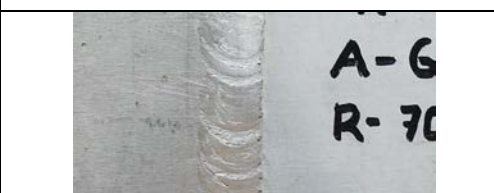
700RPM, 40mm/min (AA6061 on Advancing side)	Lack of penetrations
A2

assessment of the radiographs. In dissimilar FSW joints it was observed that base metal 6061 positioned on advancing side have fewer defects in comparison with

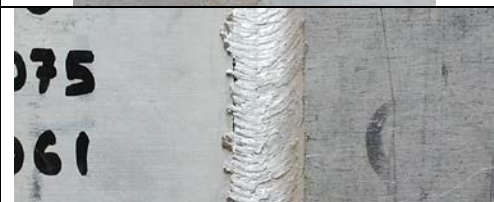
700RPM, 40mm/min (AA7075 on Advancing side)	Lack of penetrations, crack, incomplete fusion
A3

base metal AA7075 positioned on advancing side and that gives good mixing of materials.

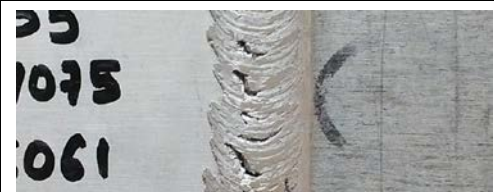
650RPM, 35mm/min (AA7075 on Advancing side)	Lack of penetrations, crack, wormhole defect

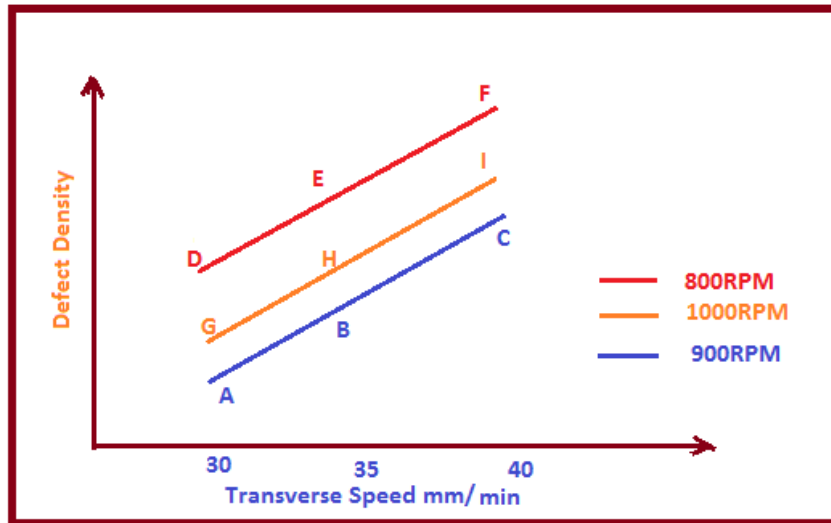
Figure 3. Defect density Vs. Transverse Speed (mm/min)

The defects found are mainly lack of penetrations, wormhole or voids. It can be seen from the results table that increasing the transverse speed increases the occurrence of defects. D has no apparent cracks of voids but revealed incomplete fusion while E shows lack of penetrations, crack, and voids. F shows lack of

penetrations, wormhole defect, incomplete fusion, discontinuity at the joint interface. With regard to tool rotational speed, it is evident that the extent of mixing is directly related to the medium rotational speed of 900 rpm, thus a more consolidated weld is achieved. Figure 3 shows a graphical summary of the trends observed from the
