Seismic Assessment of Historical Bridge: Numerical Modeling and Structural Evaluation

Abstract In this study a comprehensive survey using faro laser scanning is performed to create a realistic 3D geometry model for subsequent seismic analysis of the bridge. The seismic response of the bridge is investigated using macro modeling approach based on finite elements. The adaptation of the Concrete Damage Plasticity (CDP) material model for masonry units and the Mohr-Coulomb material model for the backfill have been implemented. Nonlinear dynamic analyzes were then performed to identify the most vulnerable areas of the bridge. The examination of the results in terms of contour plots of tensile damage and maximum displacements has provided a thorough description of the seismic response of the entire bridge. The methodology used in this study can be considered a comprehensive basis for evaluating the seismic response and failure of historic structures.

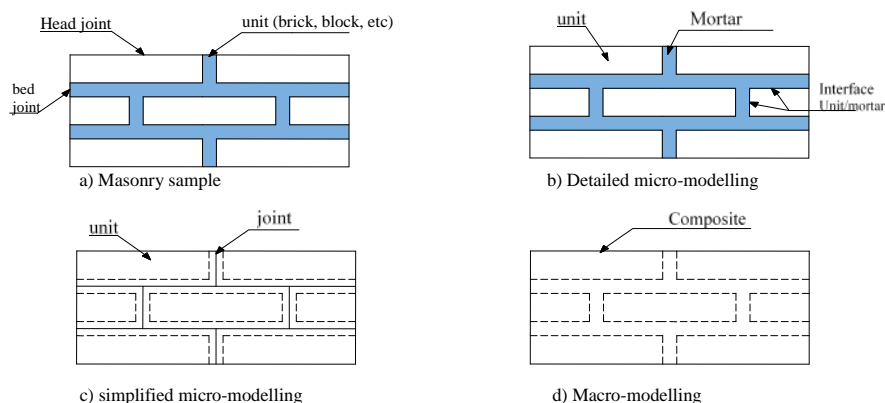
Figure 4. Material modeling techniques [25]

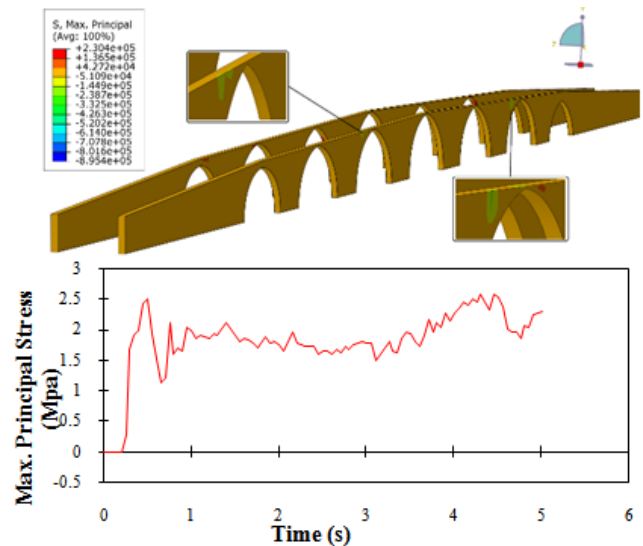
Figure 8. Maximum principal (tension) stress contour maps and time history of the spandrel walls

Figure 10 shows the counter map of dynamic displacements in the transverse directions of the bridge spandrel walls, illustrating the importance of out-of-plane structural response in masonry bridges. Figure 8 and Figure 9 illustrate that the maximum principal stresses of the masonry along the spandrel walls interface, as well as the bridge arches while subjected to strong ground motion. Figure 11 and Figure 12 depicts the time-dependent variation in the minimum principal stresses and locations of concentrated stress.

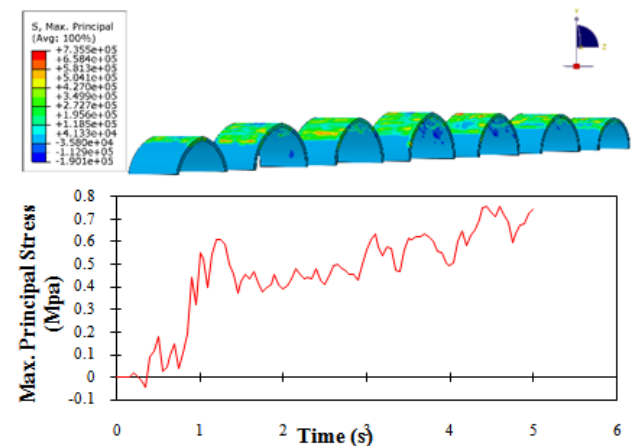
Figure 9. Maximum principal (tension) stress contour maps and time history of the arches

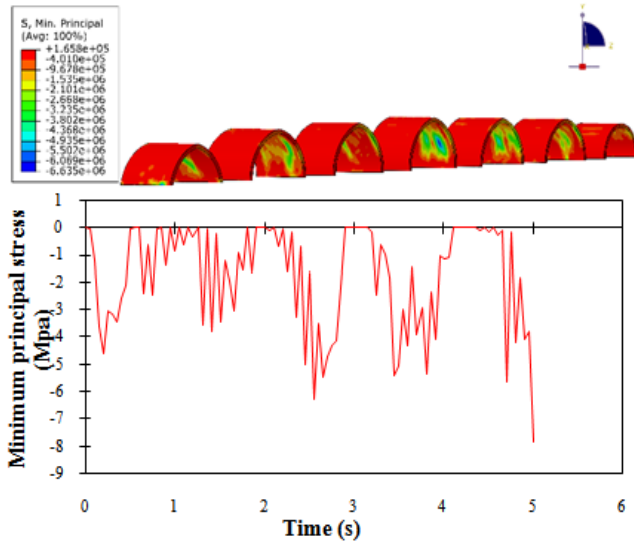
Figure 11. Minimum principal (compression) stress contour maps and time history of arches

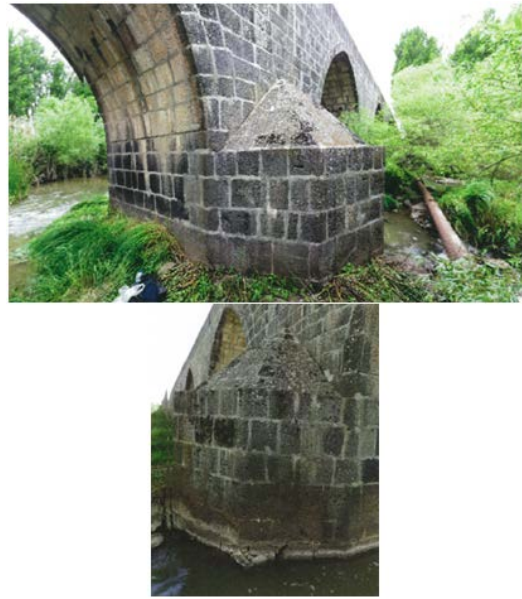
Figure 13. Corrosion of the pier due to the presence of water

- ❖ Water caused corrosion of the embedded rock and a loss of mechanical strength in the bridge's piers and abutments, according to an on-site investigation. Furthermore, vegetation was detected surrounding the bridge's piers (Figure 13). During an on-site assessment, this vegetation can conceal existing damage and is responsible for existing capillary cracking on the abutments and piers, both of which contribute to the degradation of the bridge and its components. Furthermore, several funguses (Figure 14) were detected on the stones. As water pierced the bridge's stonework, moisture deteriorated the piers and abutment stones even more. The field assessment also indicated that the mortar was of poor quality, allowing certain stones to be readily removed. Proper maintenance planning should be addressed to overcome these challenges. As a result, a reinforced concrete layer is being investigated for reinforcing and consolidating the bridge foundations. Repointing the mortar in the bridge's joints between the masonry pieces was considered. The mortar composition used to repoint the masonry joints must be carefully evaluated. The lime-based mortar should be as near to the color of the existing brickwork as feasible. These mortars should be as resistant to the region's harsh environmental circumstances (high humidity, contact with waves) as feasible while being compatible with original materials.

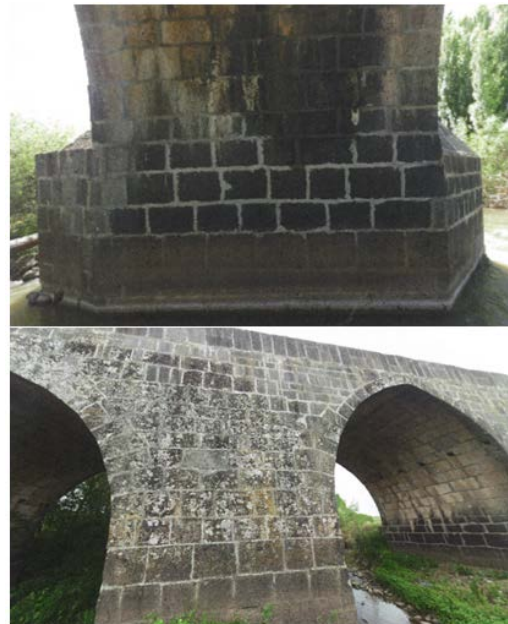
Figure 14. presence of fungus on the stone surfaces

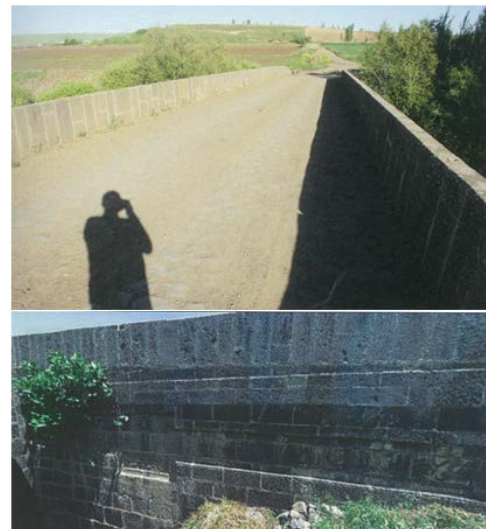
Figure 15. presence of vegetation on roadway and spandrel walls

- ❖ The route of the bridge is paved with cut and fragile gravel stones. Vegetation had overrun the road. The current vegetation may aid in compaction, but it may also obstruct waterproofing and capillary drainage. The absence of adequate drainage will cause crystallization and subsequent rotting of steel anchors, which are one of the bridge's reinforcing measures, culminating in the disintegration of the load-bearing component. As a result, all masonry viaduct elements (arches, walls, and roadway) should be properly cleansed of efflorescence using high-pressure water. Almost all of the difficulties connected with a lack of waterproofing, such as parapet damage, moisture and water penetration, material deterioration, and mortar loss in joints, will be addressed by considering the drainage system.
