Urban Fire Incidence and Planning Responses at the Bamenda Central Market, North West Region of Cameroon

Clarkson Mvo Wanie*, Edwin Mua Kang, Roland Saah Wallang

Department of Geography and Planning, The University of Bamenda, Bamenda, Cameroon

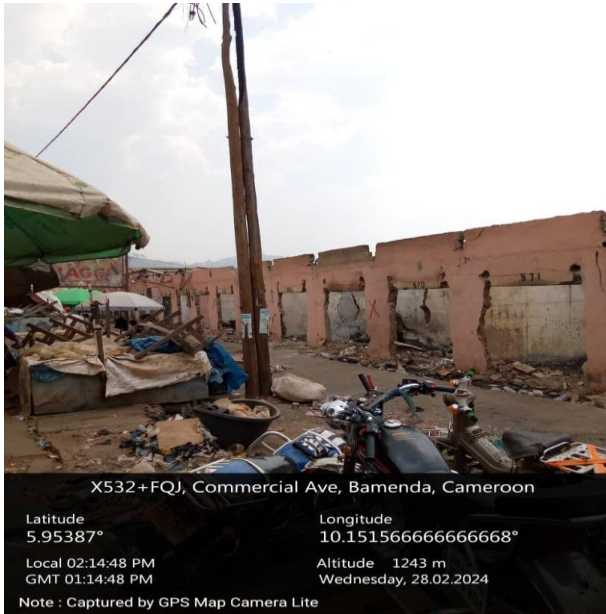
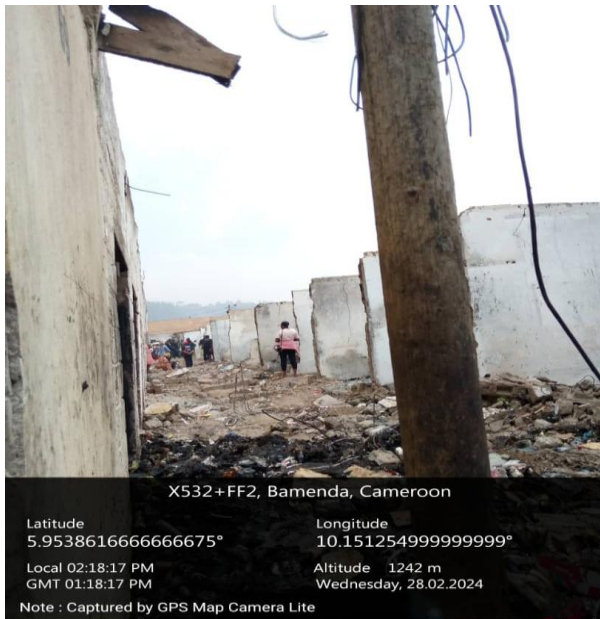
Figure 2. Uncontrolled electricity cable connection in the Bamenda Central Market

Findings showed that technological failures accounted for about 63.53% of the urban market fire triggers. Field investigation further revealed that the Bamenda Central market is characterized by uncontrolled electricity cable distributions that crisscross each other at different points. Almost all the stores in the market are electrified by different electricians. This makes it difficult to maintain steady power flow and tracing of faults in connection lines (Figure 2).

In situation of high voltage, there is usually sparking effect indicating poor connection and cable contact. Most of the stores in the Central market use low grade

distributors which are often unable to carry the power supply system. Most vendors or business operators usually turn blind eyes to this and it has been identified as one of the immediate causes to the fire incidence.

- The government should ensure complete reconstruction of the market and provide enough spacing of at least 5m from one building to another to ensure free vehicle access (such as firefighter vehicles).
- Vertical structures could also be erected in order to economize space and create space for vehicles access.
- There should equally be a modern roofing system, installation of electrical devices to detect technological failures and a standby fire fighter vehicle in the market for emergency.
- There should be regular checking of electrical cables and connection by the registered authorities.

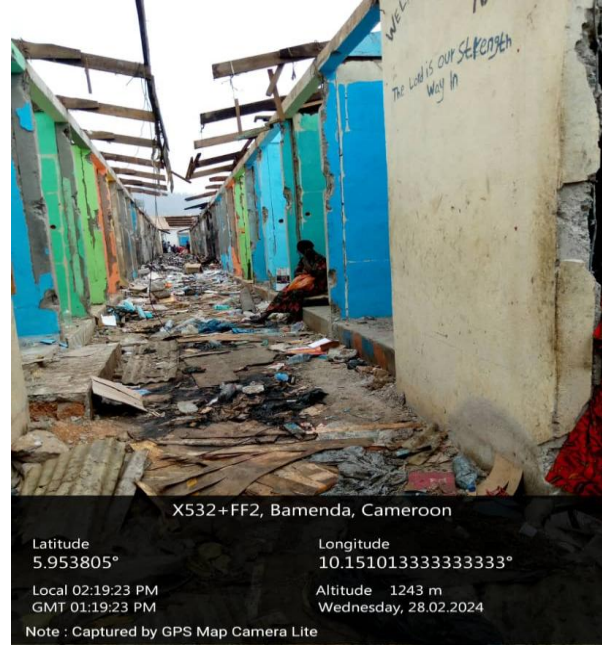
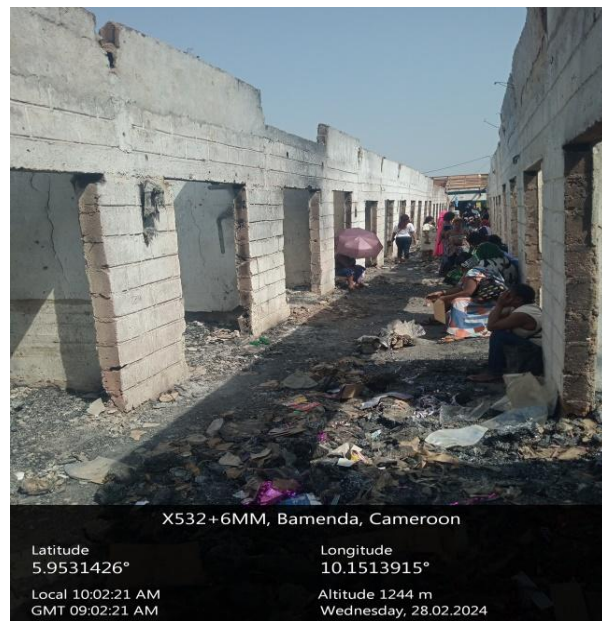
Figure 3. Insufficient spacing separating shop buildings in the Bamenda Central market

This has triggered the need for more shops by the growing economic population. In response to this effect, the market administrators reduced the spacing between buildings from 5m to 2.5m and equally extending building lanes for more shops. This action of reduce alignment of buildings precipitated fire to crossover from one building to another (Figure 3).

Findings equally revealed that the insufficient spacing did not only precipitate fire extending from one building to another but also reduce the chances of intervention from the fire fighters. This is due to the inaccessibility of the lanes by the vehicle to quench the fire. This explains why most of the shops in a particular segment had to be destroyed to enable the fire fighter vehicle have access to extinguish fire though the efforts made were not significant enough to reduce the fire disaster (Figure 4).

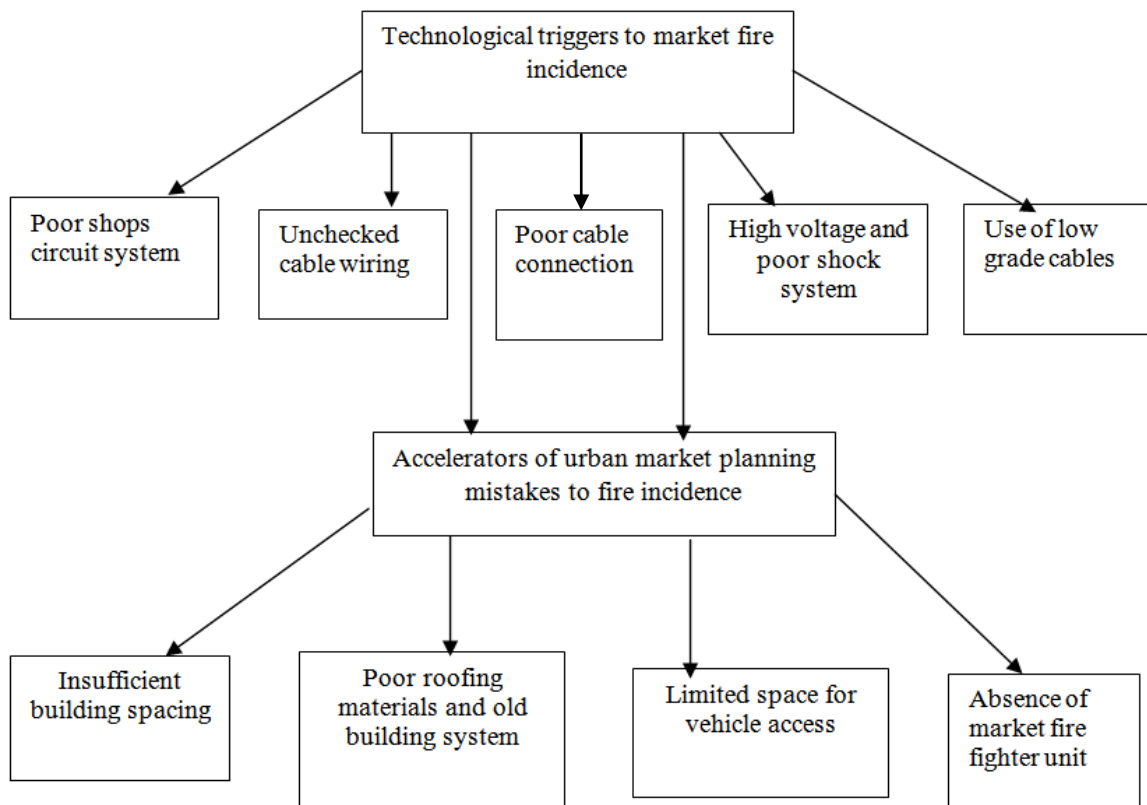
Figure 5. Simulative framework for Bamenda urban market fire triggers

market buildings are constructed almost at the same height which facilitates fire crisscrossing given that the market revealed a continuum of buildings or stores. This equally justified that effective planning in the construction of the market was not considered. **Figure 5** presents the simulative framework for the triggers of the Bamenda Central market fire incidence.

According to the framework in **Figure 5**, the technological and urban market planning mistakes work together to explain the causal incidence of the market fire in the Bamenda Central Market. This implies that most of the buildings affected were built with materials that are not heat conductors. From the study, it was revealed that “most of the things” consumed by fire were buildings with single-floor since the market is dominantly constructed at same height. Field observation held that most of the buildings in the affected market segment were low rise structures that could not pose a challenge to fire fighters. However, the closeness of the buildings did not permit effective firefighting unit to operate successfully. The framework shows that interrelatedness of the triggering mechanism or variables, in order to justify the occurrence of the fire while opting for better measure to prevent future disasters in the market in particular and other markets with similar characteristics in general.

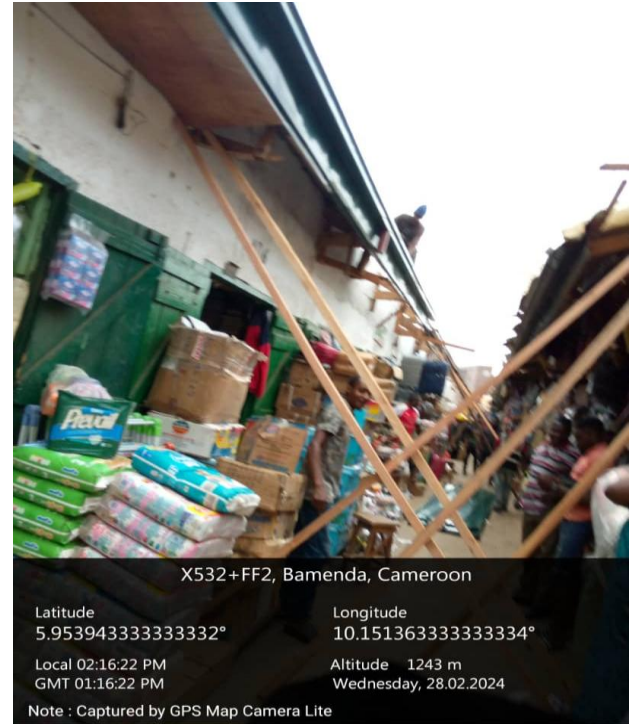
Figure 8. Individual Reconstruction of affected Shops before Planning Responses

Considering the causes and implications of the fire disaster in Bamenda Central market, the tendency is for stakeholders to react promptly, in order to prevent such incidence in future. There have been heated responses of stakeholders and planning to the victims and the municipality as a whole. According to the government delegate to the Bamenda City Council, there is definitely planning actions towards reconstruction of the market to a modern standard. This construction takes into consideration the provision of enough pathways or lanes to ensure vehicle access and building of modern shops with roofing that do not encourage fire crisscrossing. The government plan of action is to revisit the outdated plan that was used in the construction of the market some decades ago. To many, this is seen as political maneuver given that this planning action was supposed to have been put in place before the fire disaster. Many argued why the government is reactive rather than proactive in planning, especially in urban markets within the Cameroonian cities. Such planning construction process should be initiated immediately but that is not the case because some of the business operators have already embarked in reconstruction and renovation of the affected shops which is the project of the council (Figure 8).
