Analysis of Reasons of Steam Turbogenerator Failure

Abstract Steam turbogenerators are often used for production of electric energy in companies where sources of steam with necessary technical parameters are produced in technological process. Attention is devoted in the paper to state analysis of steam turbine after failure and possible causes of its damage.

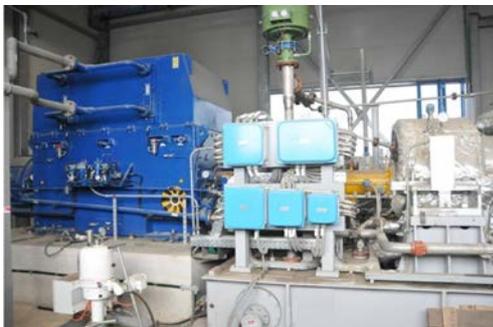
Condensation steam turbogenerator (Figure 1) was damaged after approximately one year operation and the failure was accompanied with fire of whole equipment.

Figure 1. Steam turbogenerator

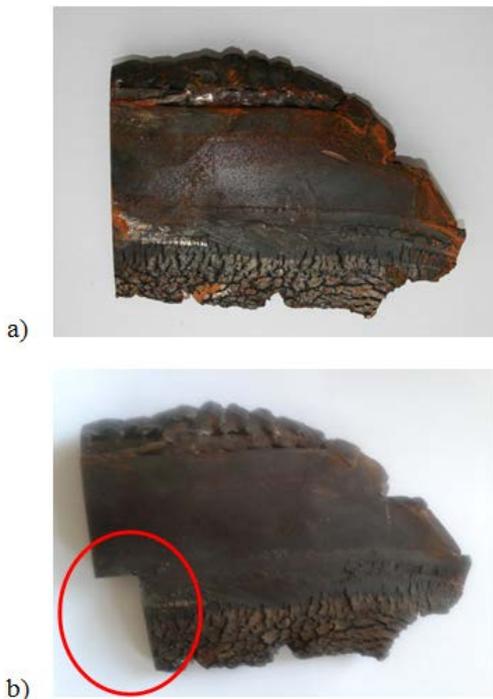
The sample A (Figure 11) was taken from damaged disc (Figure 12) in order to provide analysis of causes of failure of rotation wheel (blade holder of the fifth stage) [7,8].

Figure 11. Specimen A from separated part of rotation wheel

The test sample was taken also for metallographic investigation. Location of sampling for specimens A are apparent from Figure 11. Metallographic documentation of microstructure of sample A is given in Figure 14 to Figure 16.

Hardness of basic material with sorbit structure is in range from 340 HV10 to 390 HV10. Microstructure of surface was changed by multiple phase transformations due to thermal influences and their hardness is in range from 430 HV10 to 470 HV10.

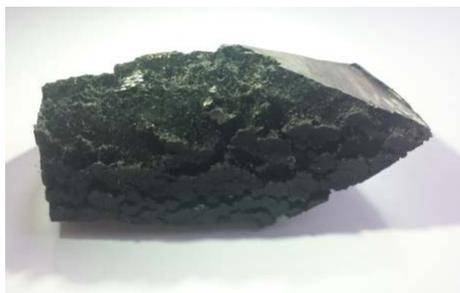
The second sampling of material (sample B in Figure 12) was realized in location of rotor (Figure 13).

Figure 12. Specimen B from the part of rotor that remains on the shaft

Microstructure of sample B is similar to that of sample A. Hardness determined for sample B was cca 280 HV10 for basic material and cca 450 HV10 for surface layer.

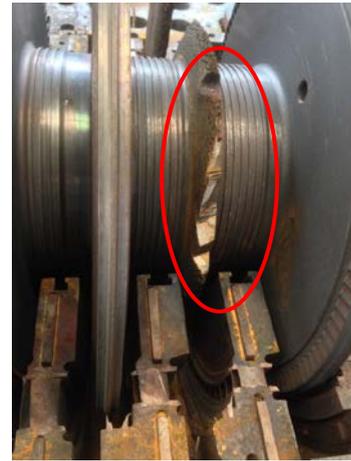
Figure 13. Location for taken specimen given in Figure 12
